# **STRUCTURAL ASSESSMENT**

## **Full Metal Jacket Building 0 Prince Street, Alexandria, VA**

ALPHA CORPORATION (Alpha)  
1850 S. Loudoun Street, Suite 200  
Winchester, VA 22601

September 22, 2010

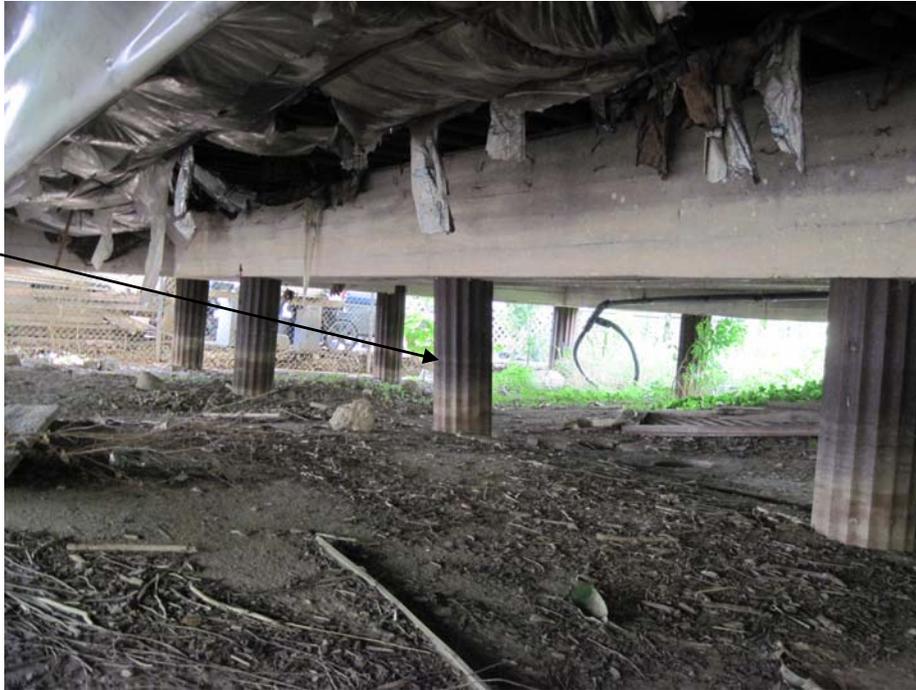
**Photograph 1**

All foundation piers were also observed to be in good to fair condition with only one pier at the center girder significantly out of plumb. Photograph 1 was taken within the crawl space and the out of plumb pier is visible. It is possible that the pier was installed out of plumb and does not indicate movement over time.

Out of Plumb  
Pier

The foundation is in good condition; however, the masonry wall and concrete beam cracking indicates that the structure is undergoing differential settlement and requires repair implementation. It is our recommendation that new drilled piers be installed to support the existing concrete beams that are located at the first floor level. To install these new piers, sections of the existing floor will need to be removed to allow for pier installation from inside the building at the first floor level. Once piers have been installed, they would then need to be attached to the existing girders to stabilize the building. After the foundation is stabilized, the removed sections of floor will require replacement. The foundation rehabilitation efforts won't jack the structure back to original;

however, the work will stabilize and alleviate any future movement. Estimated costs for foundation stabilization are \$75,000.

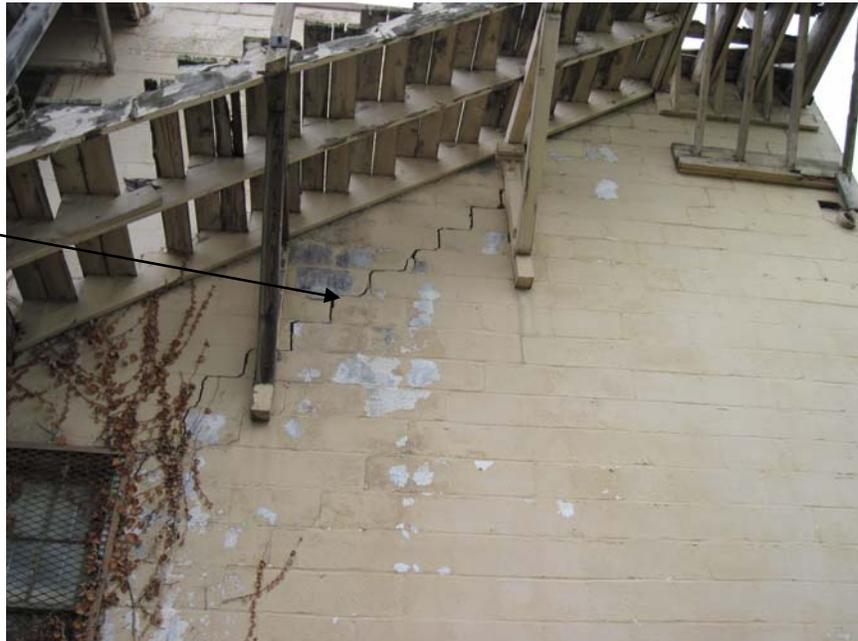
**Photograph 2**

From outside of the building, a large stepping crack was found in the north wall. Photograph 2 was taken of the north wall. The crack was found to extend from the roof level down to the window sill elevation of the first floor windows.

Large stepping  
crack

The crack in the north wall was also visible from inside of the building at the second floor level. Exterior sunlight was visible for most of the crack's length indicating full penetration of the crack and separation of the wall. Hairline to 1/16" wide stepping cracks were also found to be present at each first floor level window extending from window sill elevation down to the wall's concrete support girder. Photograph 3 was taken of the north wall at the first floor elevation. Vertical cracking through the concrete masonry units is visible. Vertical cracking through a unit indicates higher stresses experienced by the CMU as compared to step cracking along grout lines and is most likely caused by differential settlement of the supporting elements.

The exterior CMU bearing walls show significant signs of cracking and likely indicate foundation differential settlement. Once foundation repairs as described above have been completed, we recommend that all walls be repointed with new mortar and vertical control joints be added at a maximum of 40' to help alleviate and control any future cracking. Estimated costs for repointing and control joint installation are \$40,000.

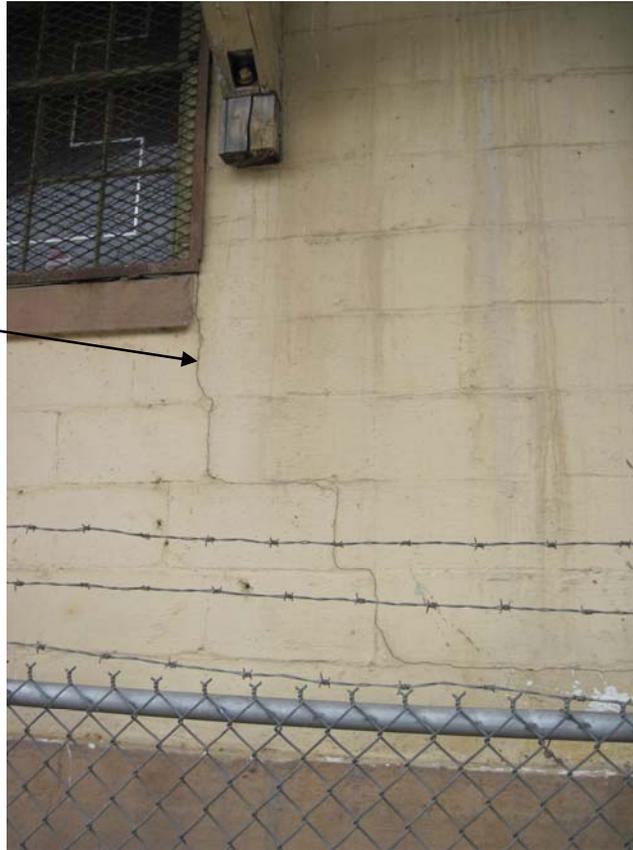
**Photograph 3**

Vertical cracking  
through CMU

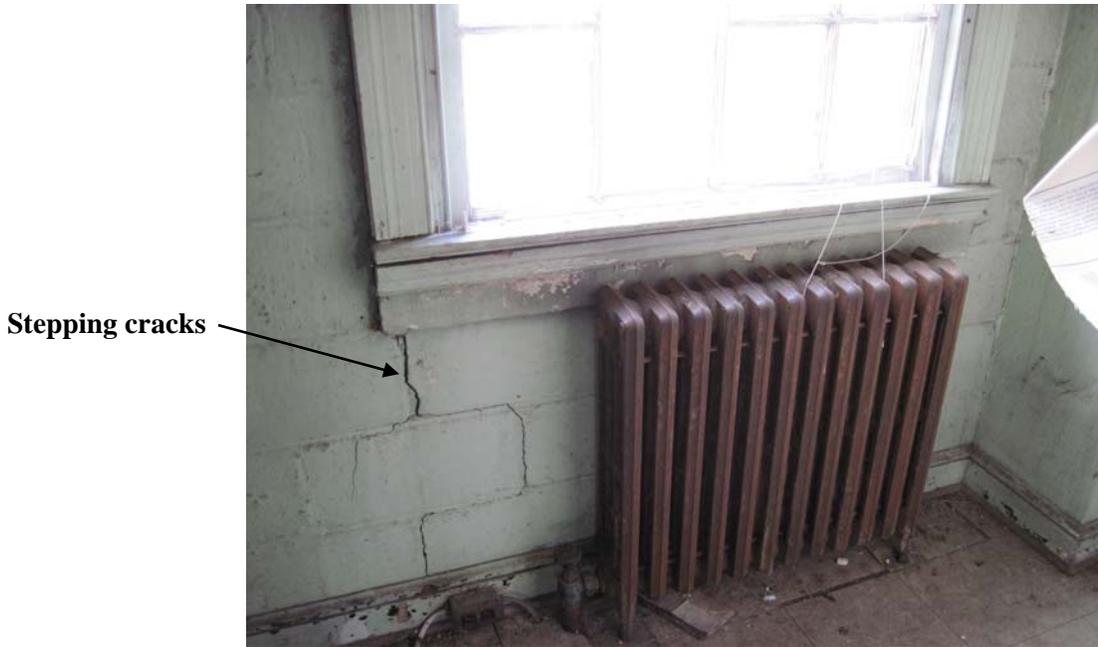
**Photograph 4**

The west and south exterior walls were observed to contain stepping cracks located at most windows extending from window sill elevation down to floor level and into the concrete beam below. Cracks occurred at both first and second floor level windows and are visible in Photograph 4. Cracks in these walls appeared to be limited to 1/16" wide or less and to follow existing masonry grout lines. At the time of observation, the east wall was found to be generally without cracking at both at the first and second floor levels.

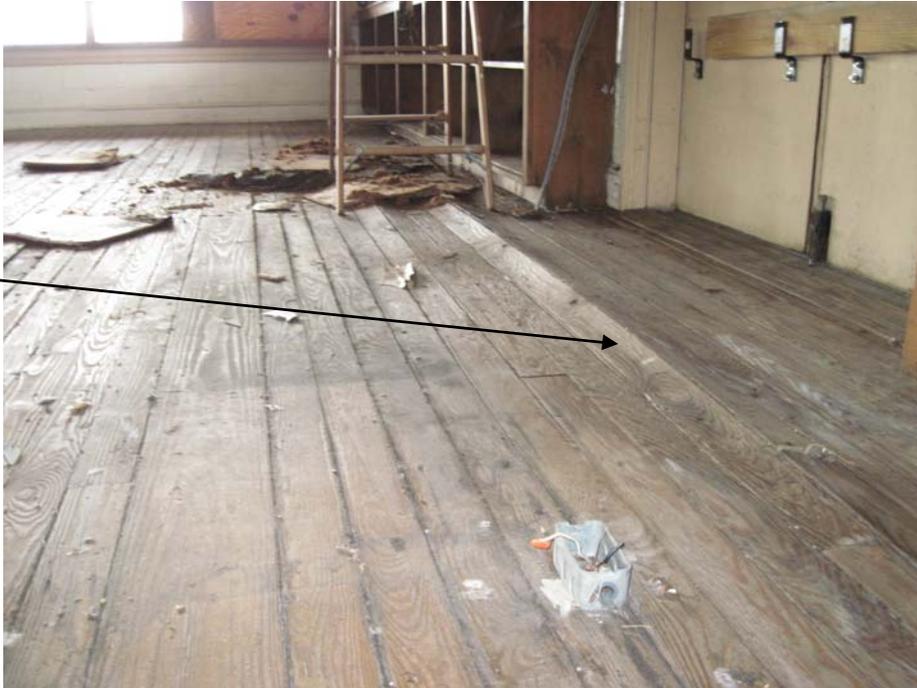
**Photograph 5**

The floor planking at each level appeared to be in generally good structural condition with only localized areas of buckling and warping or water damage found at each level. Photograph 5 was taken of the first floor showing warped floor planks. Photograph 6 was taken from the second floor level looking up at the roof framing showing water damage.

**Warped floor plank**

Existing floor and roof systems appear to be in good condition overall with only localized member replacement required. Where floor decking has buckled and warped, the individual planks should be removed and replaced. Where signs of prolonged moisture exposure occur, the planking and supporting joists should be replaced in kind. Estimated planking that requires replacement is 20%. Where the floor is sloped excessively in the first floor room to the East, the floor system will require re-leveling. Estimated costs for shimming and re-leveling are \$5,000.

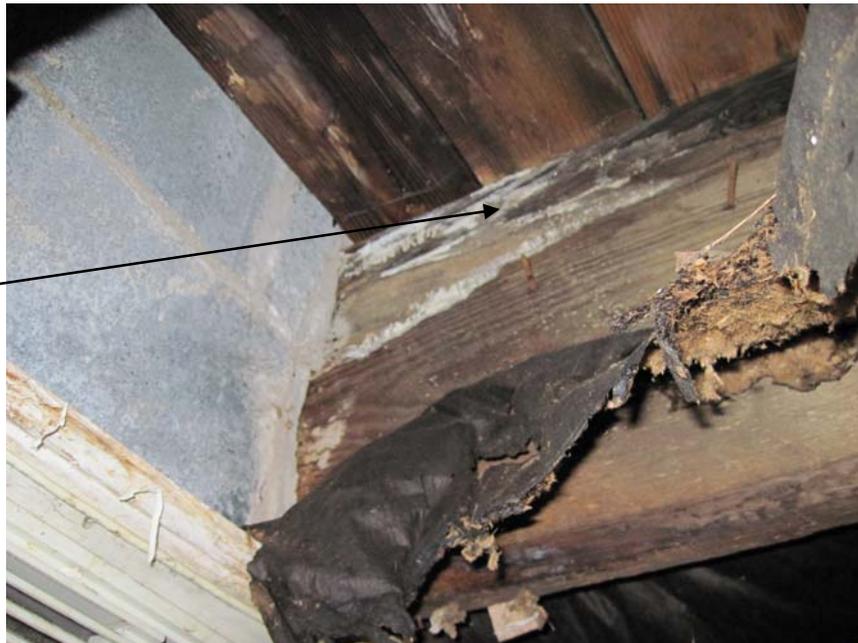
**Photograph 6**

**Moisture Damage**

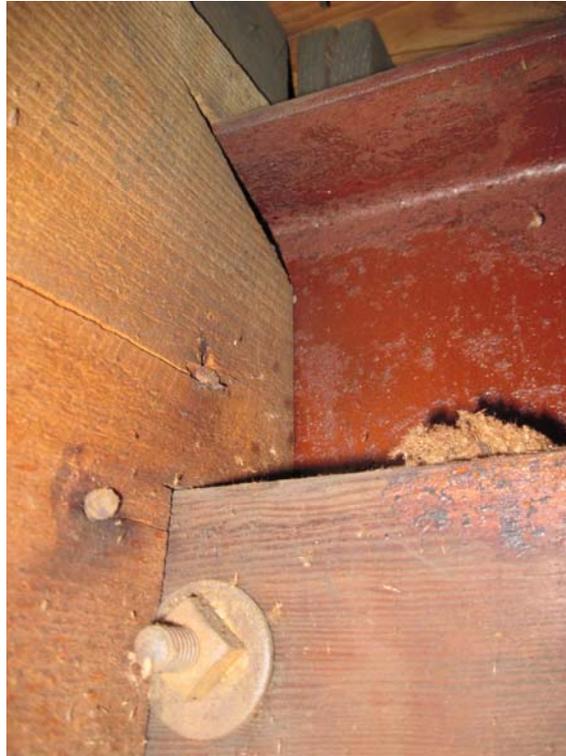
**Photograph 7**

Floor and roof framing appeared to be in generally good condition with only a few locations indicating minor to moderate moisture damage. Photograph 7 was taken of a typical connection showing the wood to be in good condition.

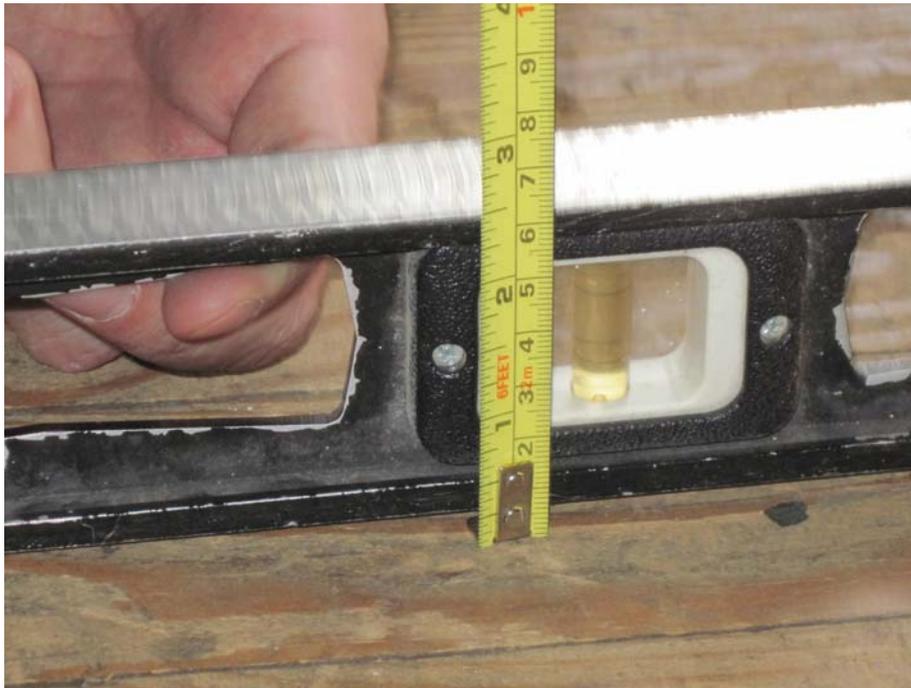
**Photograph 8**

At the first floor level, the first 27' of the floor measured from the east exterior wall was observed to slope down toward the exterior wall approximately 1/4" in every 30" of run. Photograph 8 was taken of the level measurement. Other areas of the first and second floors appeared to be generally flat with little measurable slope.

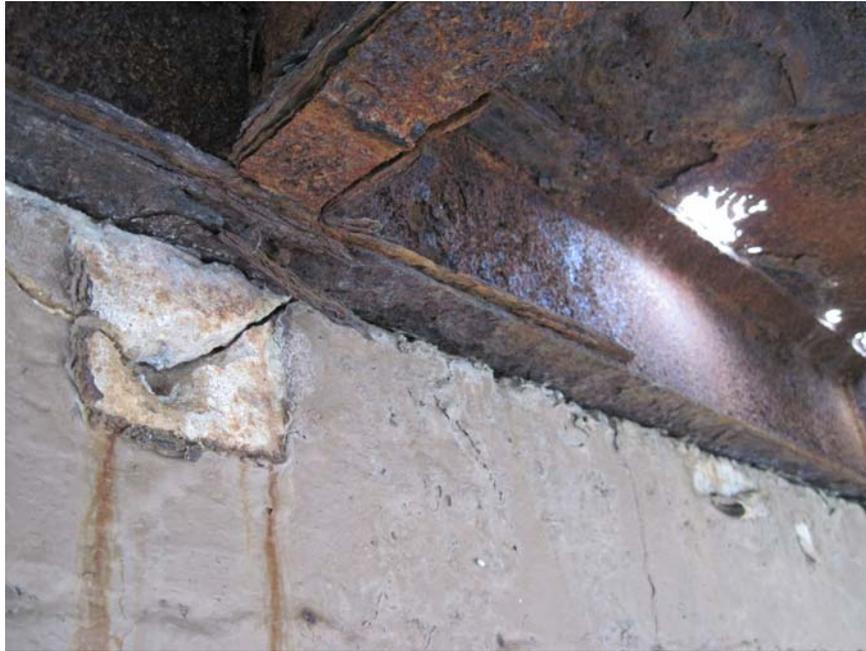
**Photograph 9**

The loading dock is constructed of a steel plate over structural steel columns and horizontal framing members. The condition is very poor with columns, connections and framing members having severe deterioration to the point of major section loss. Photograph 9 is taken from under the loading dock showing deteriorated framing. Photograph 10 shows a girder to column connection with rust and warping. The loading dock includes a set of pressure-treated wood stairs. These stairs and their connections were also observed to be in poor condition showing signs of moderate to severe deterioration and weathering.

The loading dock is in a severely deteriorated state and is no longer able to support its required loading. We recommend that the existing loading dock be demolished and removed. Estimated costs for demolition are \$5,000.

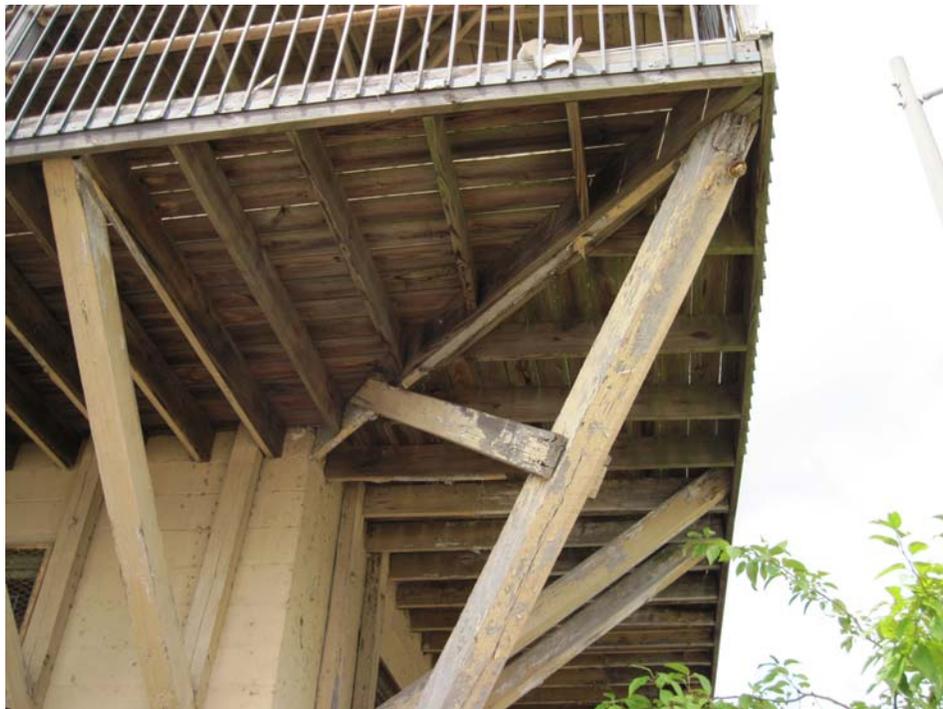
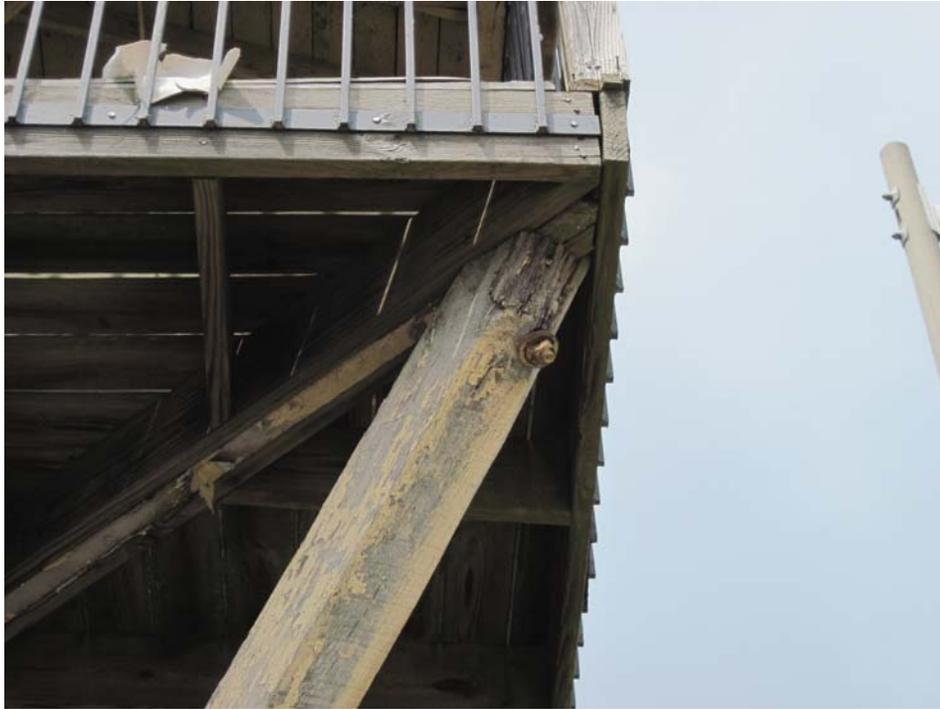
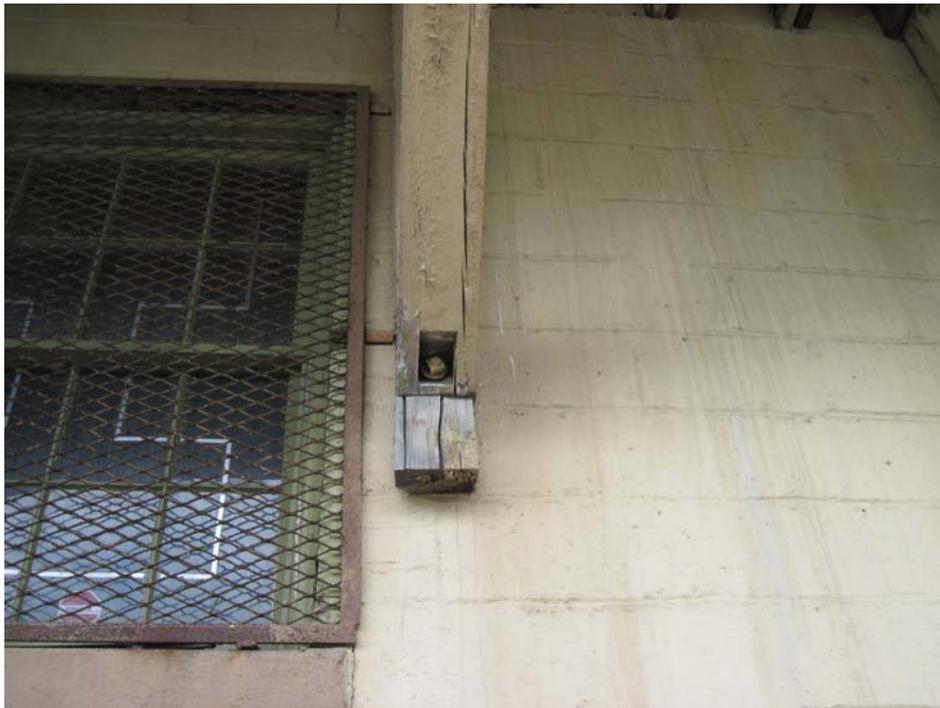
The porch floor decking was observed to be in good to fair condition. The cantilevered floor joists were observed to be in poor condition, while the pressure-treated floor joists spanning between wall and porch perimeter were observed to be in fair to good condition. However, the non-pressure-treated knee braces and porch band boards were found to be in a state of severe deterioration with large splits and checks at connection locations and severe deterioration of metal fasteners. Photographs 11-13 were taken from street level looking at the underside of the porches showing the deteriorated braces and connections.

Overall the elevated covered porches are in poor condition and can no longer safely support building code required loads. With the current condition of primary framing members and their connections, we recommend that the existing porches be demolished and removed in the near future. Estimated costs for demolition are \$15,000. Immediate concern exists for the exterior stairs along the north wall which are in danger of failure and dropping to the public sidewalk below. Removal is highly recommended and has already been discussed with City of Alexandria personnel.

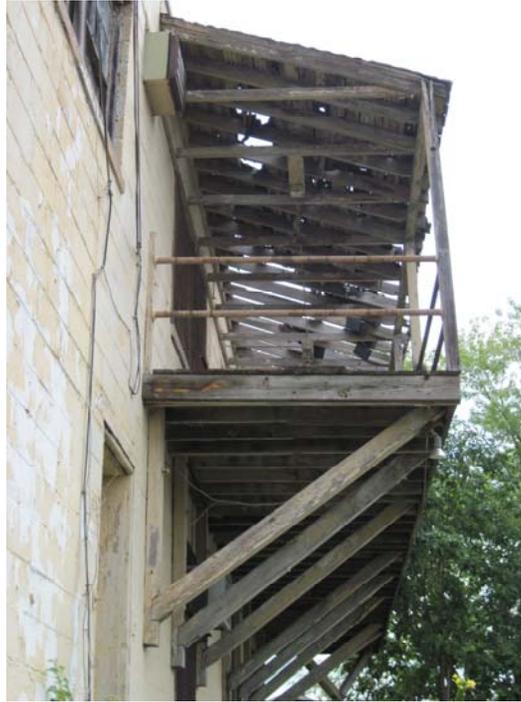
**Photograph 14**

The porch roofs were observed to be constructed of 2x roof decking laid flat over sloped 2x wood rafters. Rafters were supported by the exterior masonry walls and by wood girders over 4x4 vertical posts at the porch perimeter. The porch roof system was found to be in a severely deteriorated condition with large areas of roof decking section loss, severe framing member

weathering, and connection failures. Photograph 14 was taken of the east porch showing holes in the porch roof.
