CHRIST CHURCH

THE HISTORIC STRUCTURE REPORT

CHRIST CHURCH
ALEXANDRIA, VIRGINIA

John Milner Associates
309 North Matlack Street
West Chester, Pennsylvania

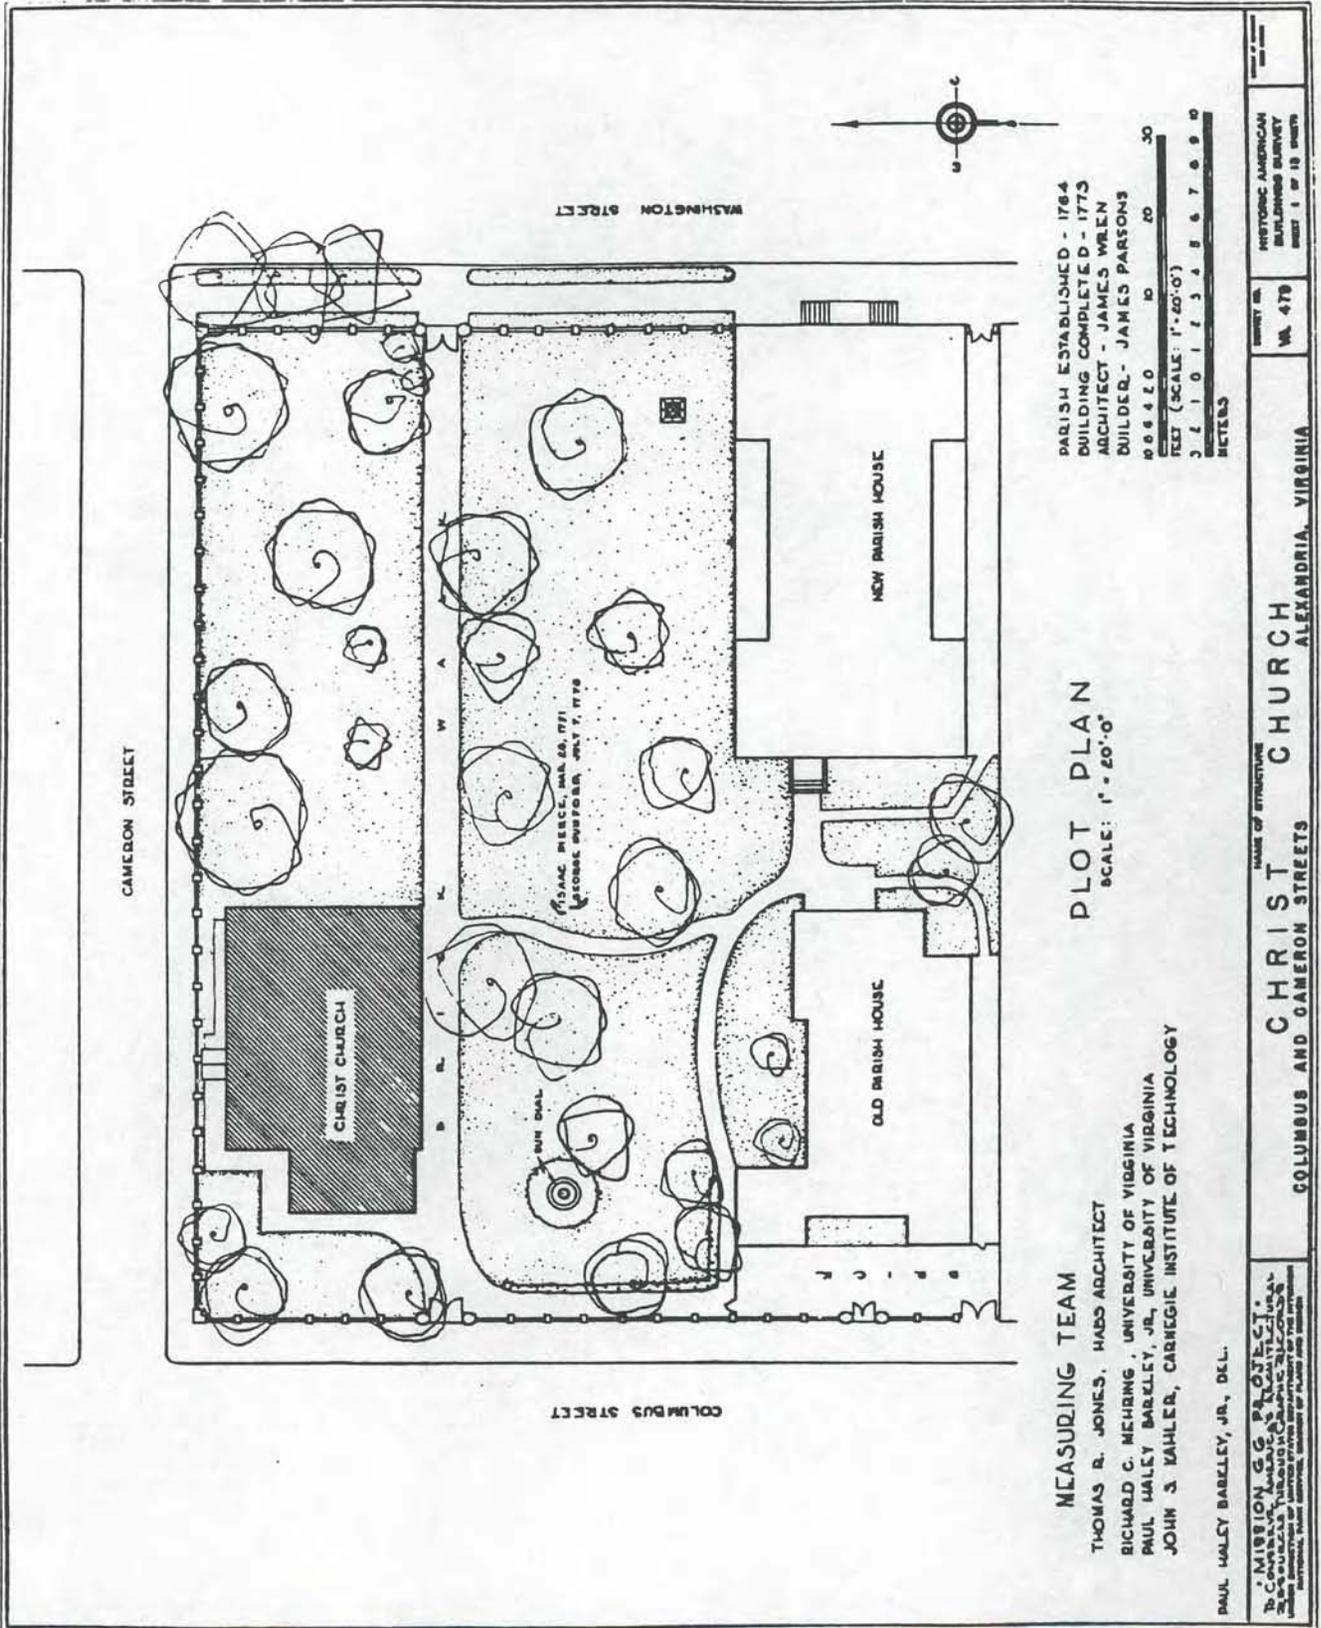
Figure 2

Christ Church, Alexandria, Virginia
 Courtesy of Historic American Buildings Survey

(See
Figure 2)

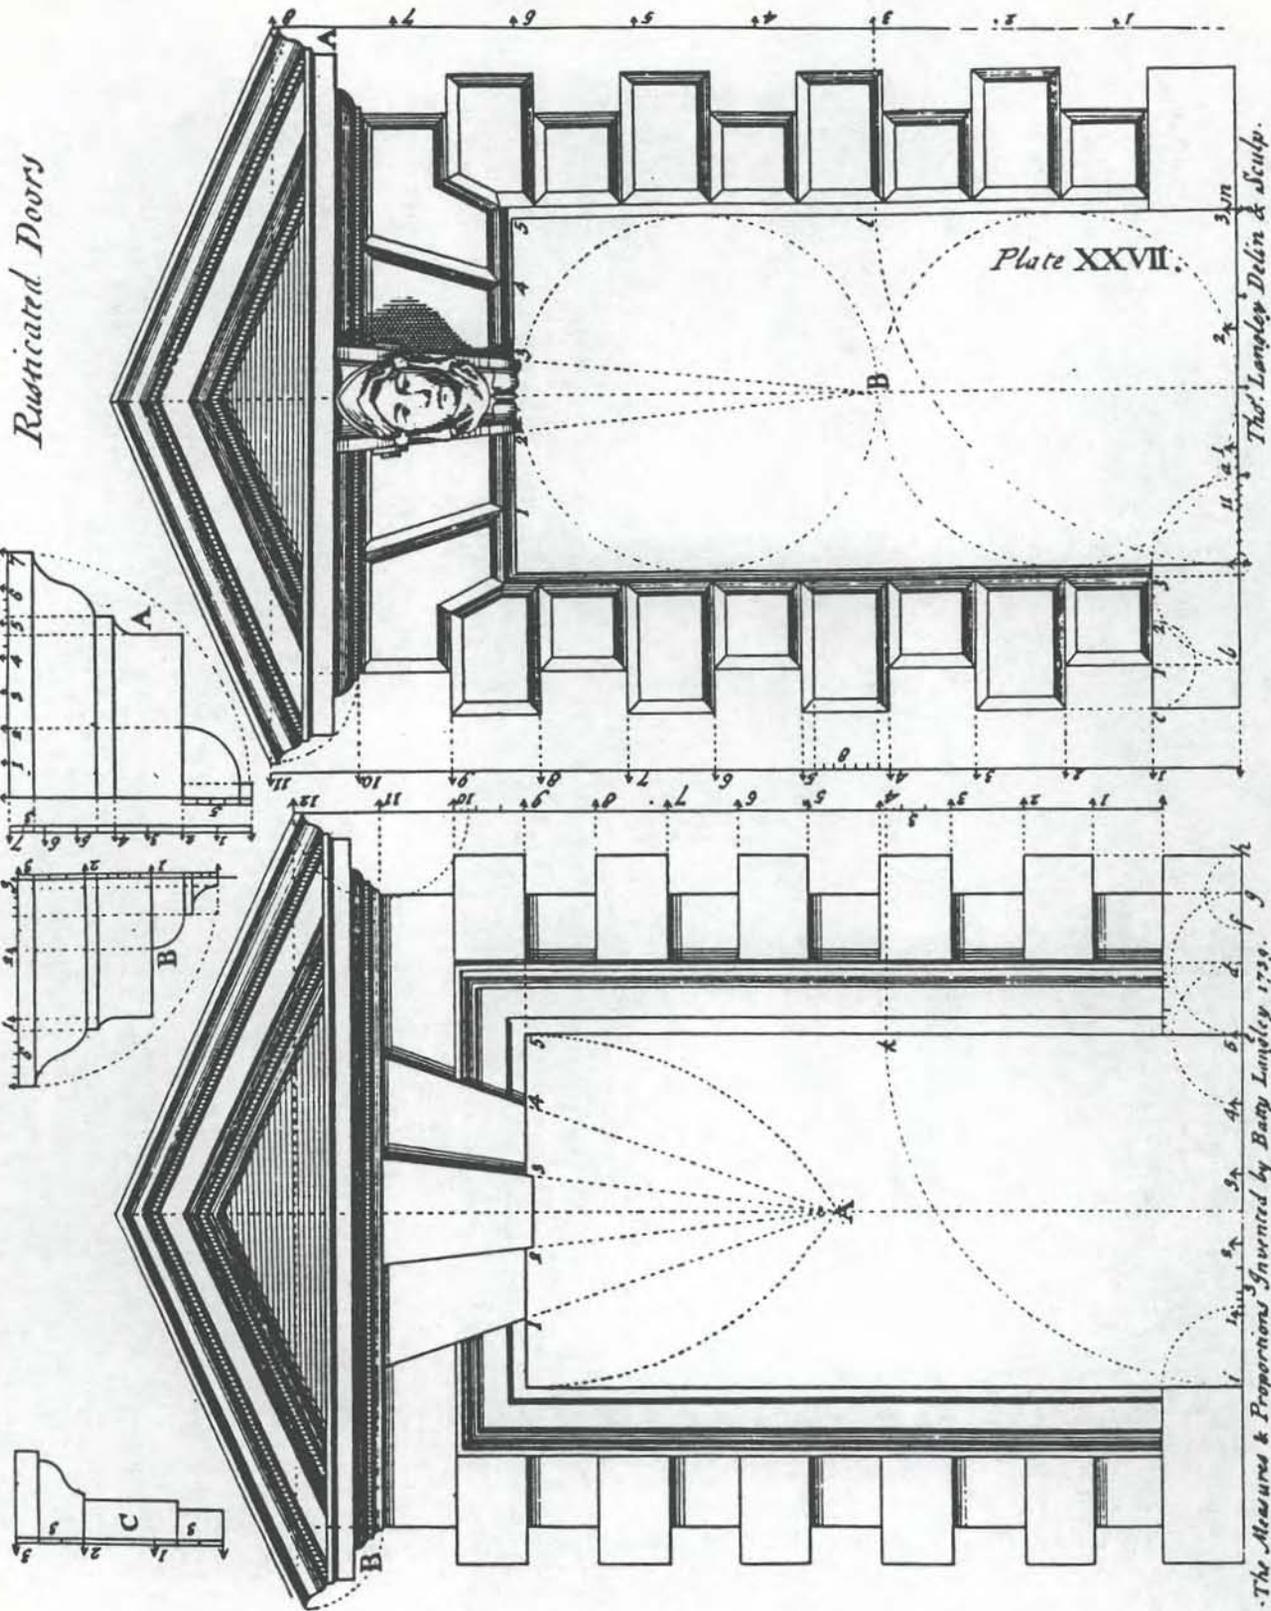
Figure 3

Rusticated Door Frame

(See
Plate 7)
(See
Figure 3)

(See
Figure 3)

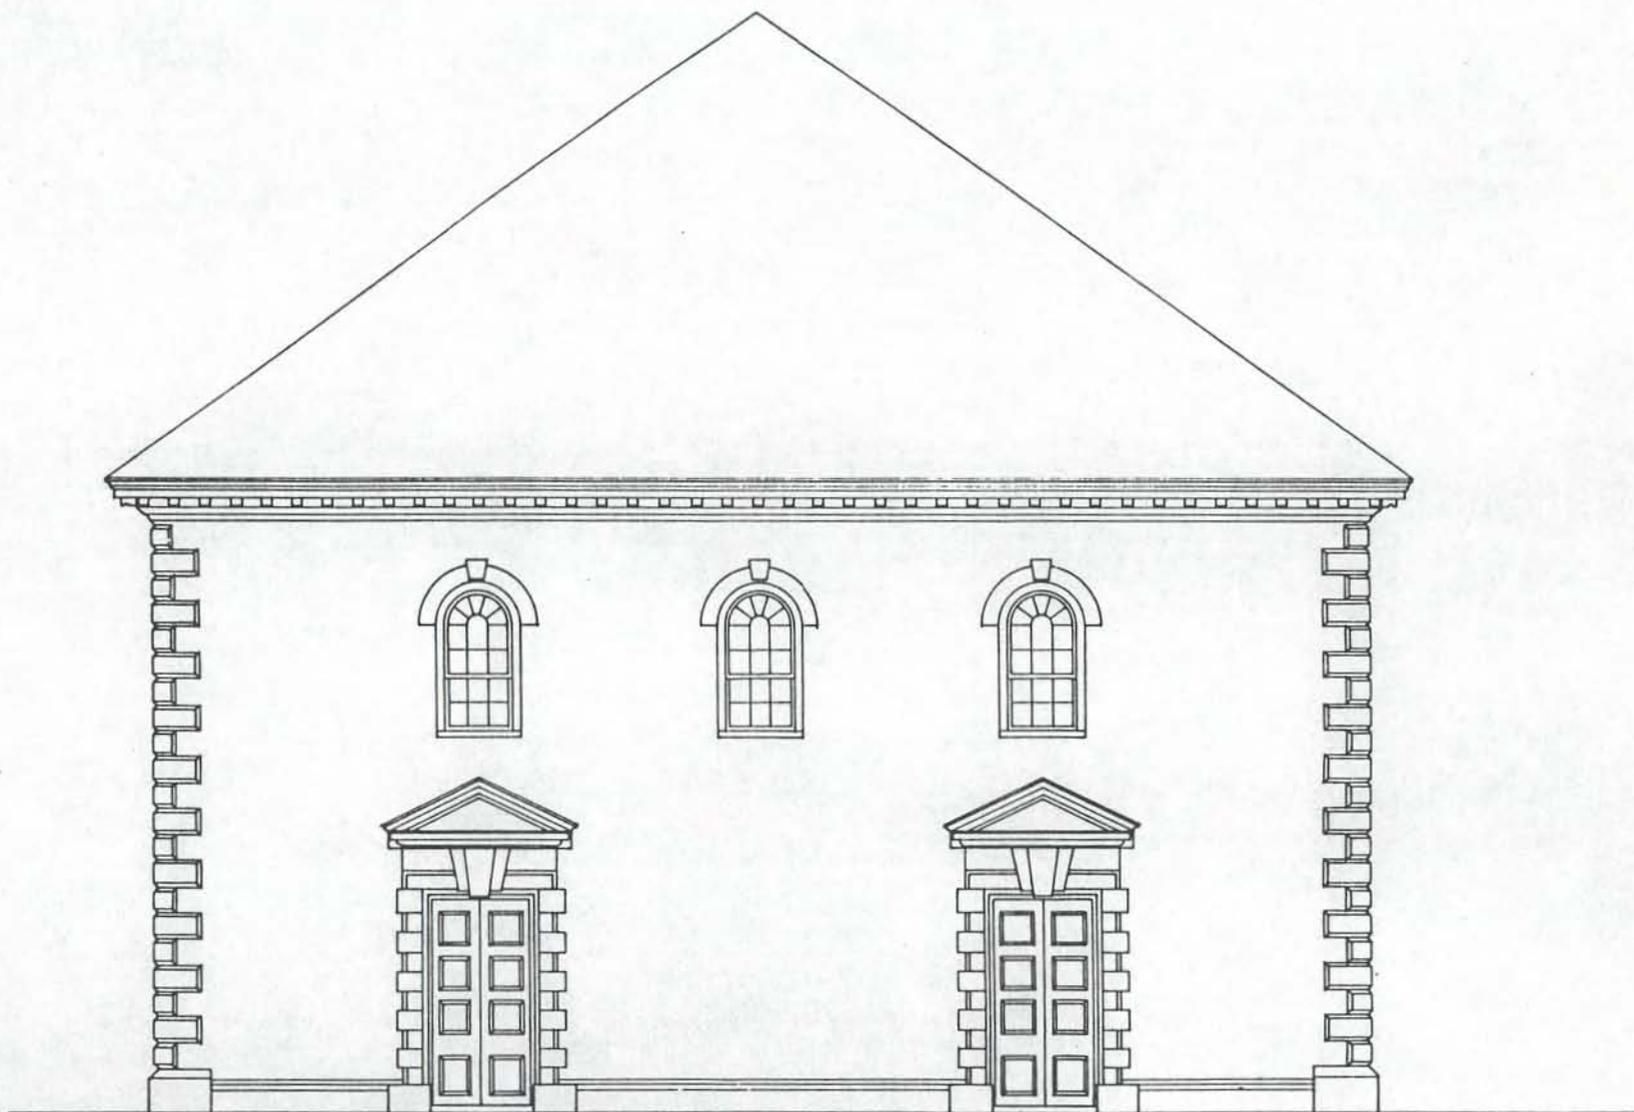
Figure 4

WEST ELEVATION: CIRCA 1773

doors with their rusticated stone surrounds (Gibbs) were in their present location, contrary to popular opinion. The second floor had three round-headed windows. It is uncertain whether there was a window opening between the entrances. The importance of the rusticated door surrounds would be adequate fenestration for this elevation. However, the plan of the Church does not eliminate the possibility of a window in this location. The window would not have conflicted with the pew arrangement; furthermore there is a window at Pohick Church in this location. The placement of a doorway in this location during the nineteenth century eliminated necessary evidence to come to a definite conclusion on this item. (See Figure 4)

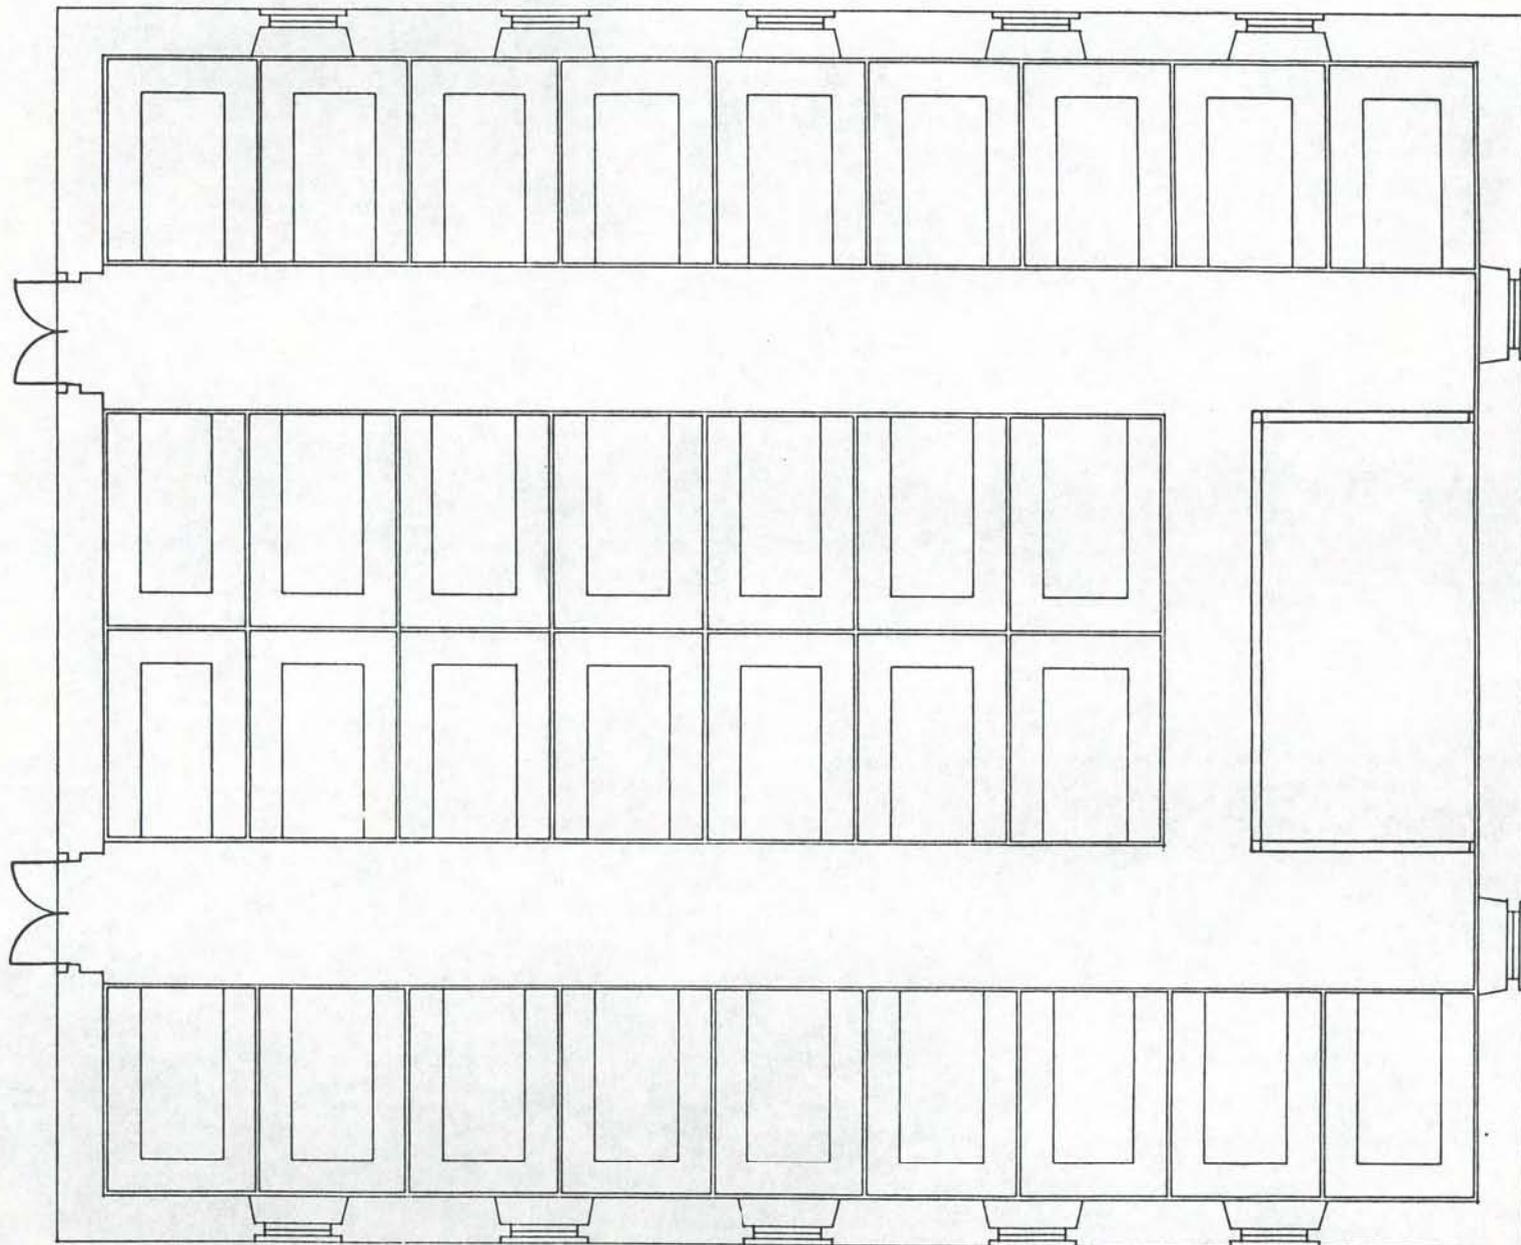
Figure 5

FIRST FLOOR PLAN: CIRCA 1773

The original plan of the Church is of great interest. Though the interior has undergone successive modifications, a good deal of information is evident. The paneled wainscot in the Church clearly marks the location of the pews around the perimeter of the Church. Conjectural restoration of the plan shows thirty-two pews on the ground floor with two aisles running in an east-west direction flanking the chancel. (See Figure 5)

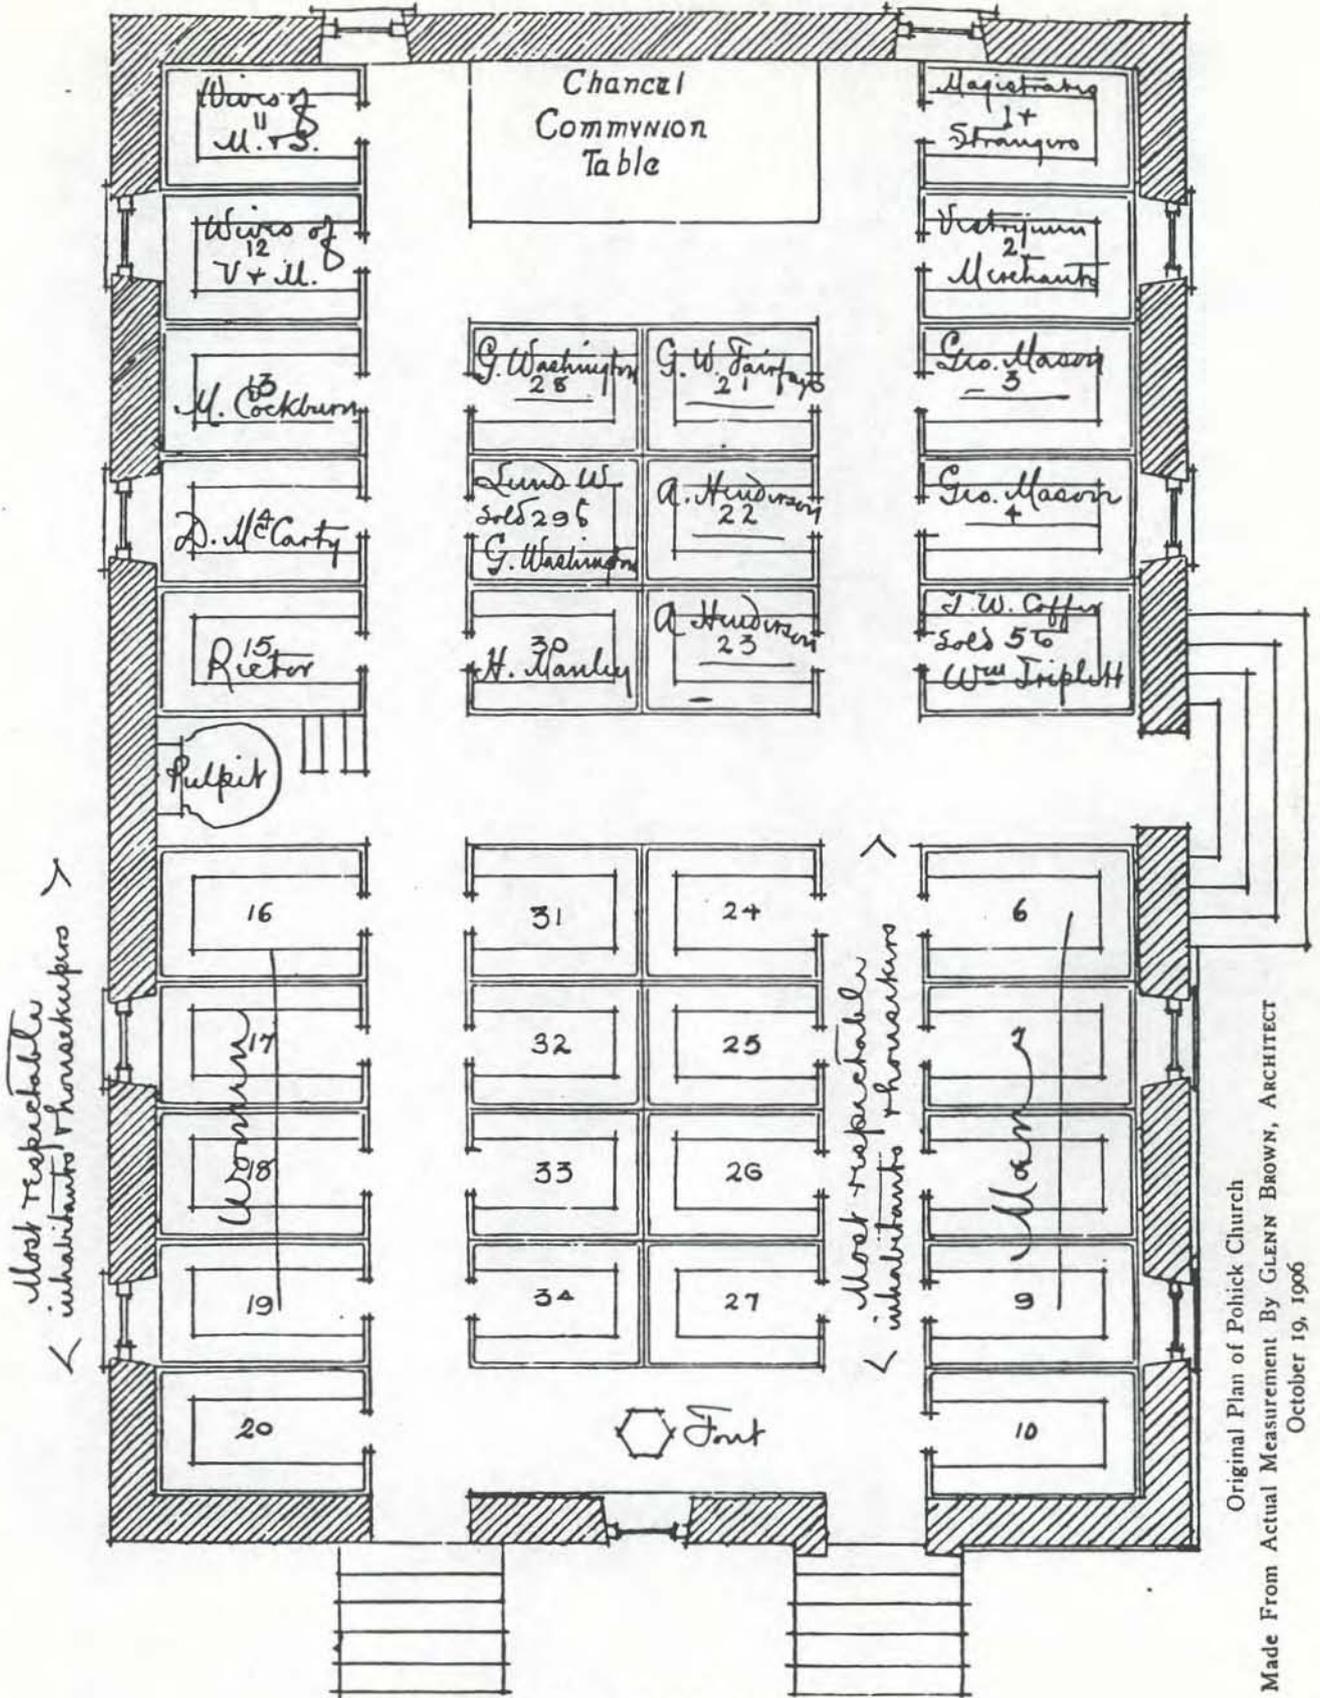
Figure 6

Original Plan of Pohick Church
 Made From Actual Measurement By GLENN BROWN, ARCHITECT
 October 19, 1906

Plan of Pohick Church contained in
 Slaughter, Philip. The History of Truro Parish in Virginia, Philadelphia, 1907.

(See
Figure 6)

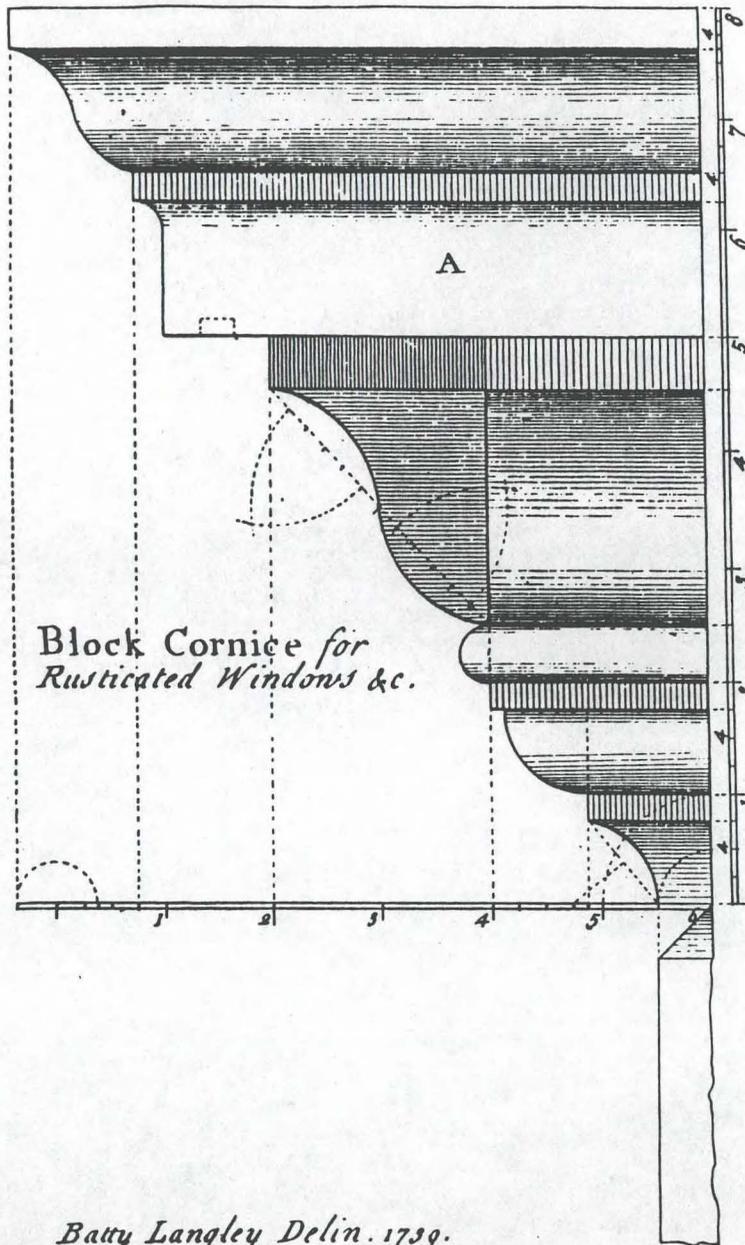
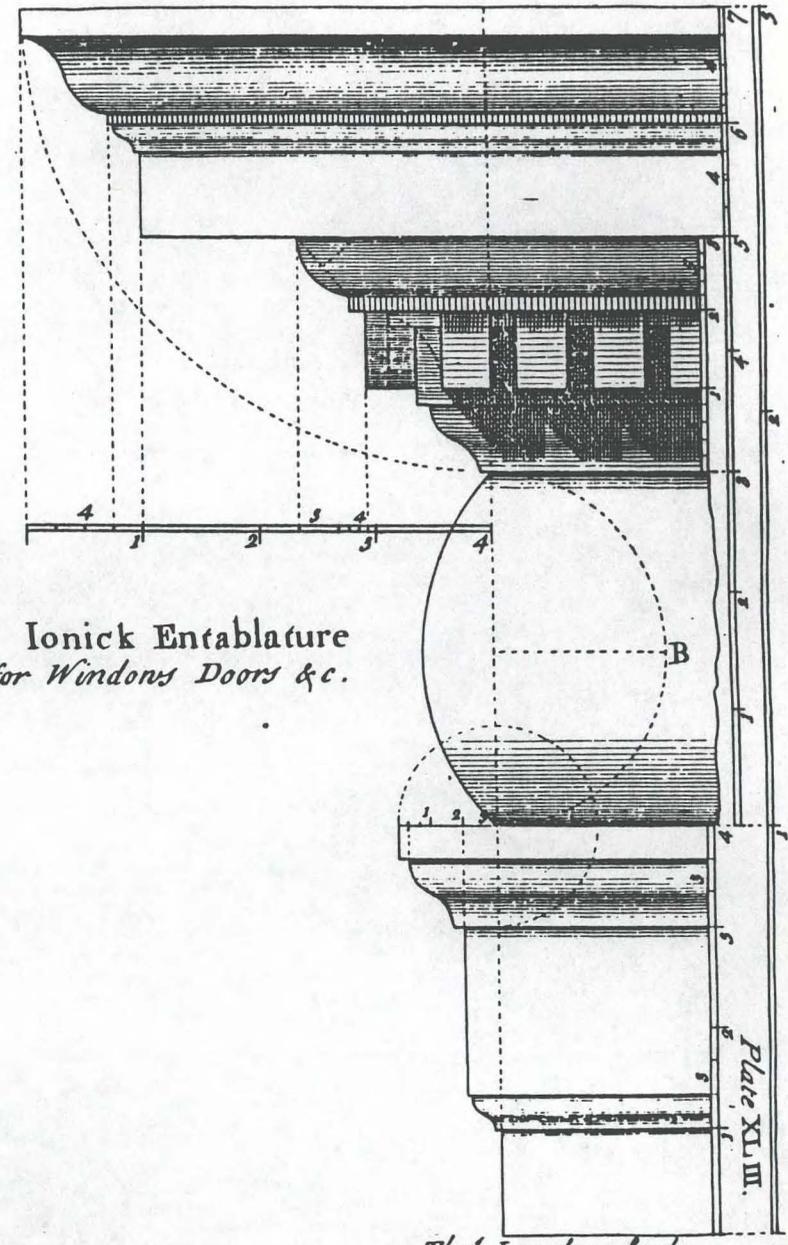
Figure 7 Ionick Entablature for Windows, Doors & c.
Plate XLIII Batty Langley Builder's Treasury of Designs

Block Cornice for
Rusticated Windows &c.

Ionick Entablature
for Windows Doors &c.

(Figures
7, 8, & 9)

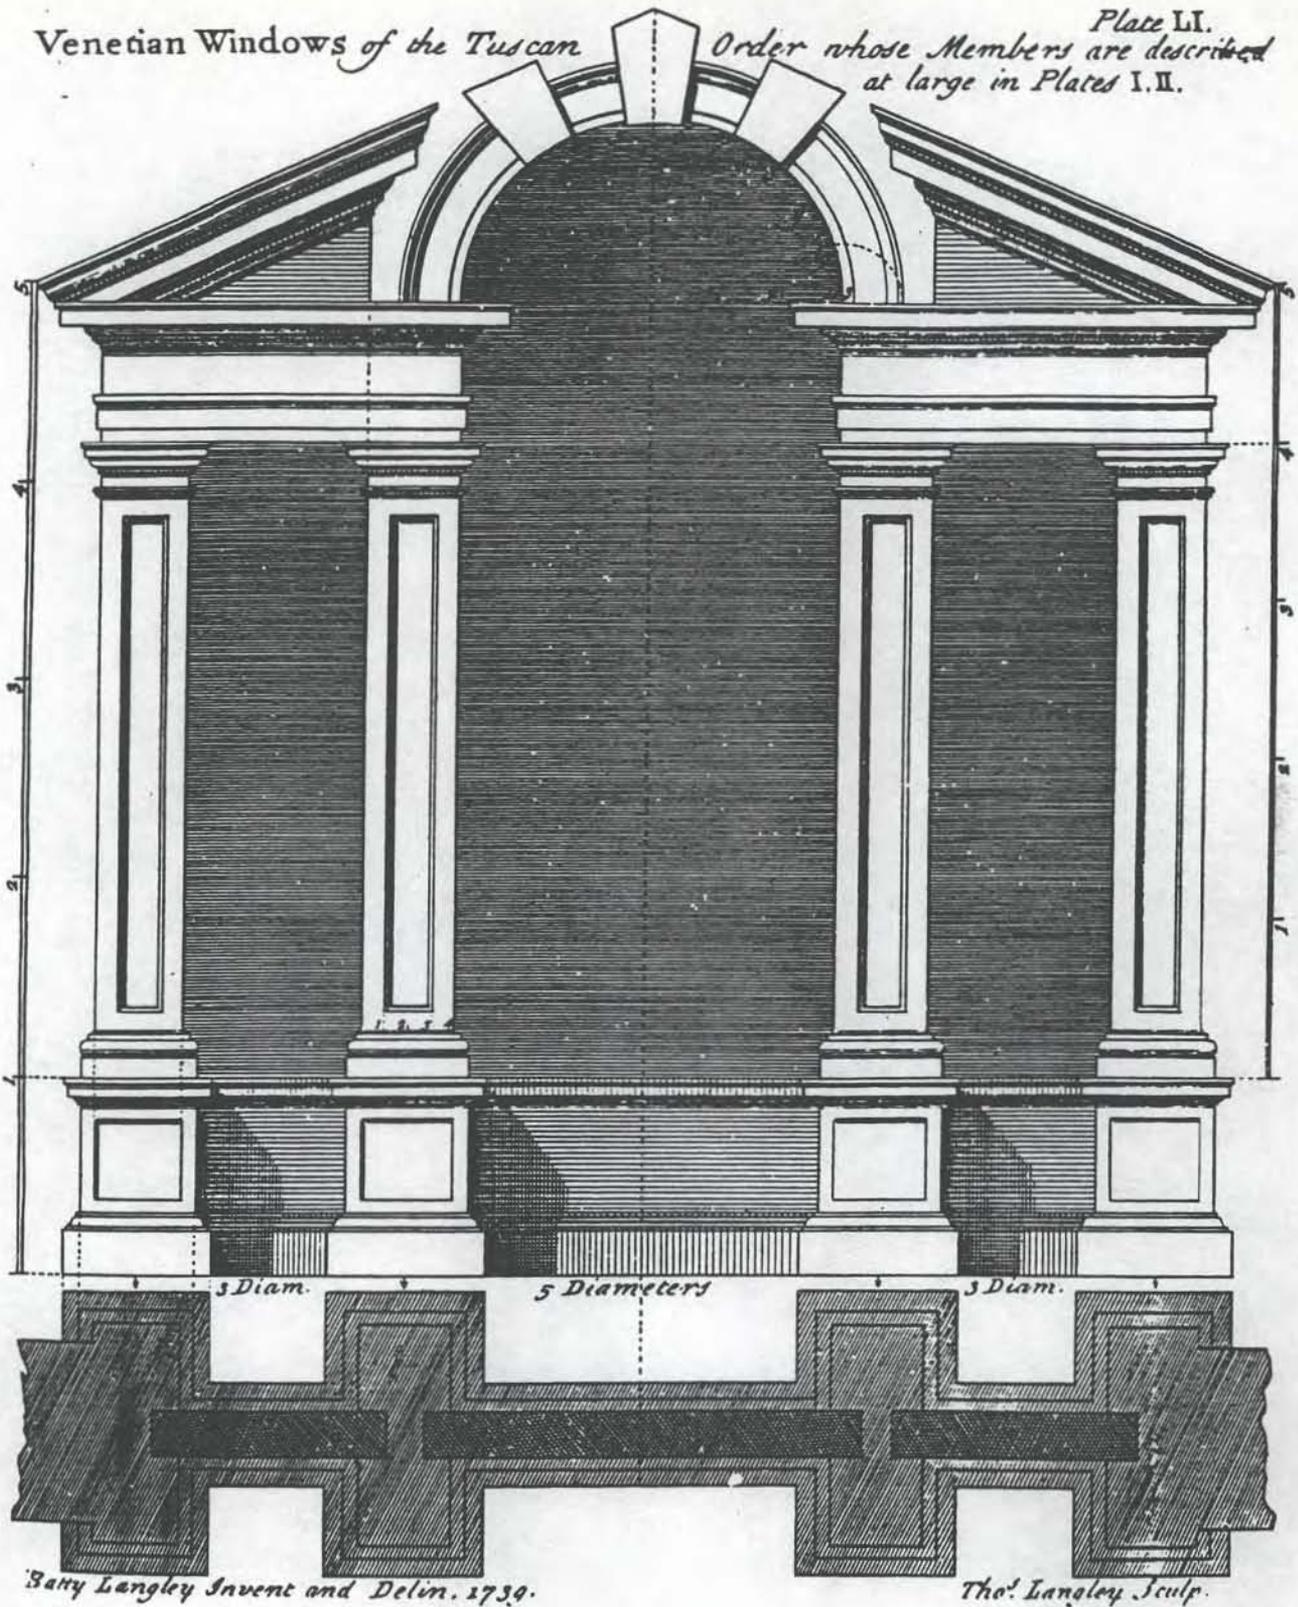
Figure 8 Venetian Windows of Tuscan Order
 Plate LI Batty Langley Builder's Treasury of Designs

Venetian Windows of the Tuscan Order whose Members are described at large in Plates I. II. Plate LI.

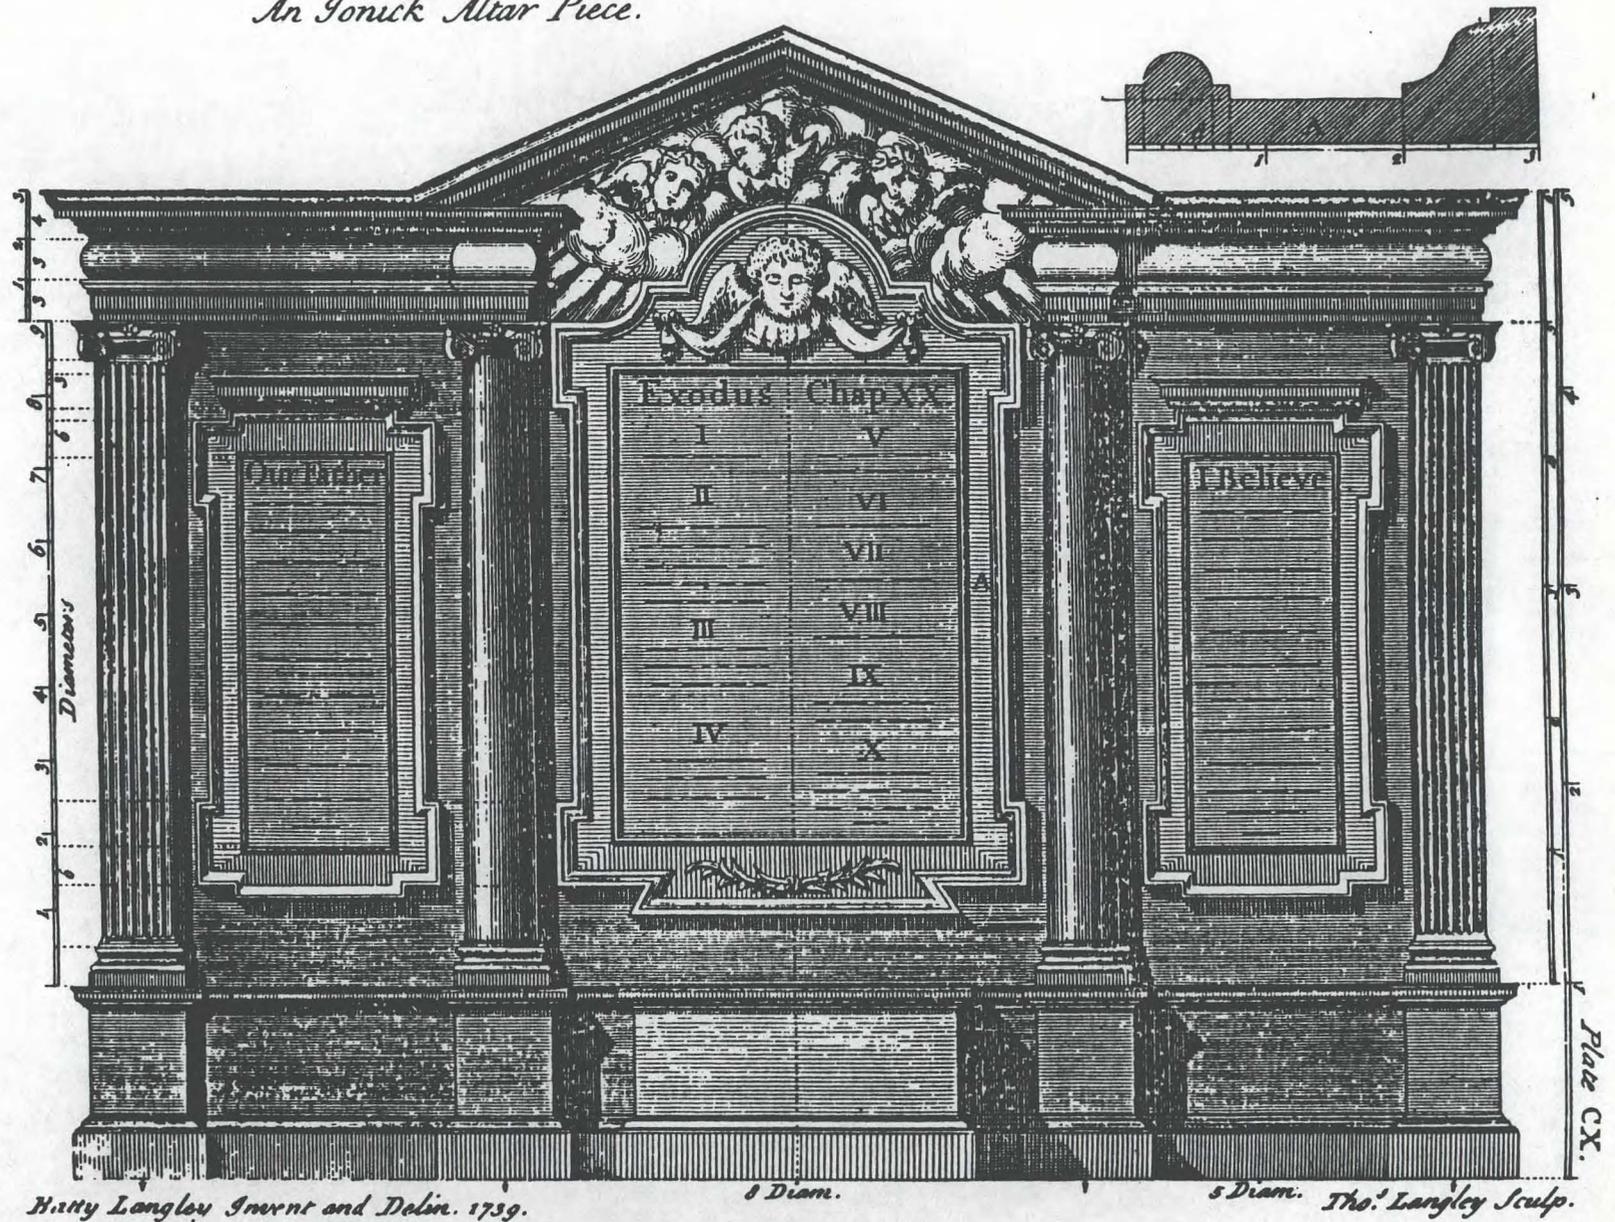
Figure 9 An Ionic Altarpiece
 Plate CX Batty Langley Builder's Treasury of Designs

An Ionick Altar Piece.

NOTE: The incorporation of the Lords Prayer and Apostles Creed in tabernacle frames are almost identical to those in Christ Church.

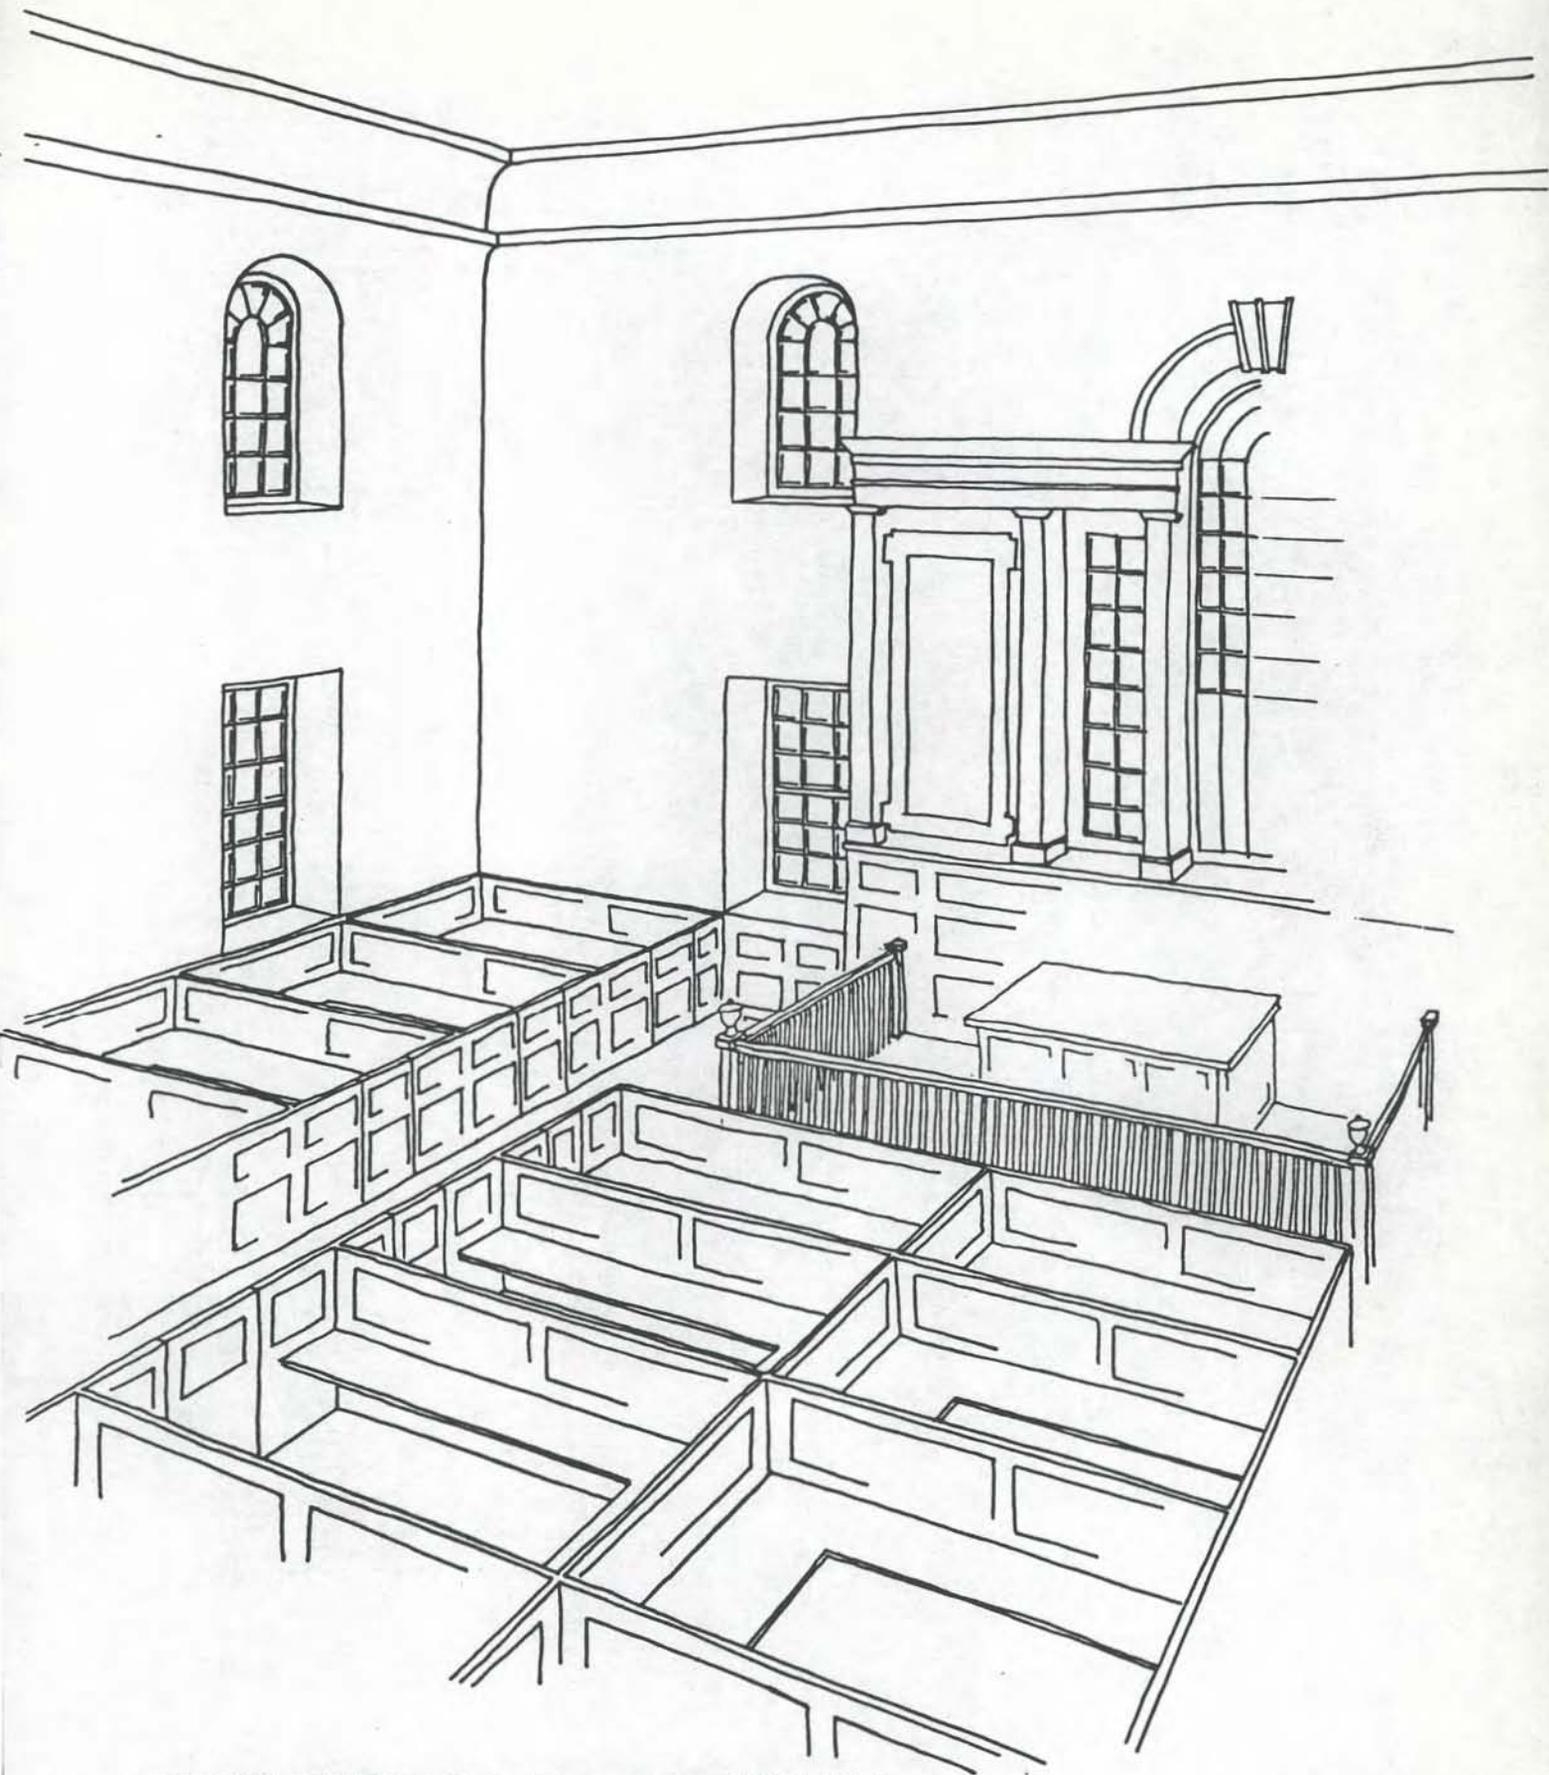
Figure 10

The space as completed in 1773 was extremely fine. The absence of the gallery created a space far more open than the way the Church appears today. The plaster walls were left unpainted or whitewashed. Millwork, including windows, doors, the chancel rail, and the alterpiece, appear to have been painted a French Grey -- the combination would have been most striking indeed.

INTERIOR PERSPECTIVE looking east: CIRCA 1773

(See
Figure 10)

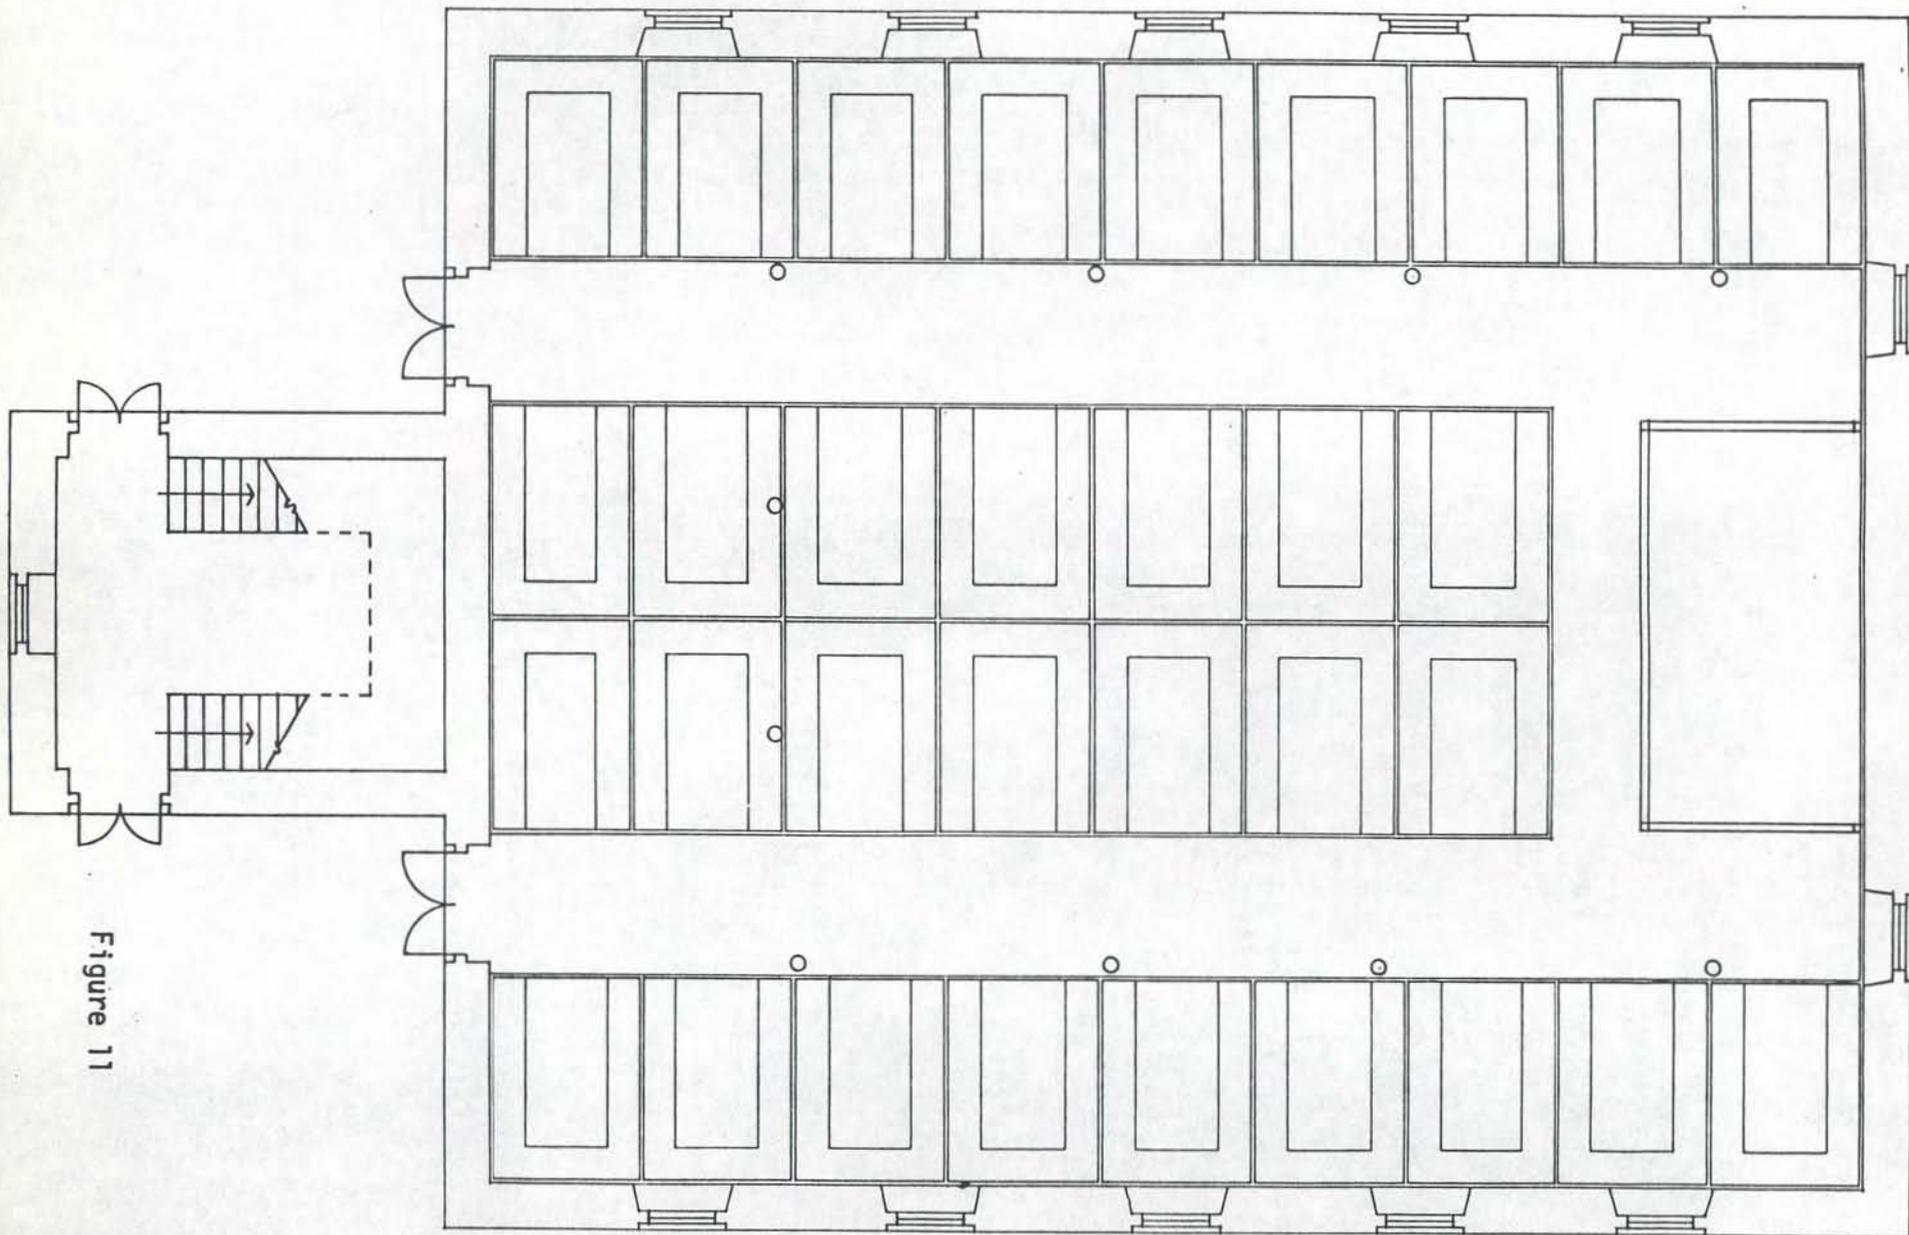
Figure 11

The installation of the gallery does not appear to have caused any major changes to the ground floor, though certainly the entire interior of the Church would have been repainted at that time. The columns which carried the gallery were placed in the aisles and, therefore, did not interfere with the pew configuration. The stairs to the gallery were not in the body of the Church and provisions were made for the gallery entrance to be through the tower. The gal-

FIRST FLOOR PLAN: CIRCA 1785

(See
Figure 11)
