CHRIST CHURCH

THE HISTORIC STRUCTURE REPORT

CHRIST CHURCH
ALEXANDRIA, VIRGINIA

John Milner Associates
309 North Matlack Street
West Chester, Pennsylvania

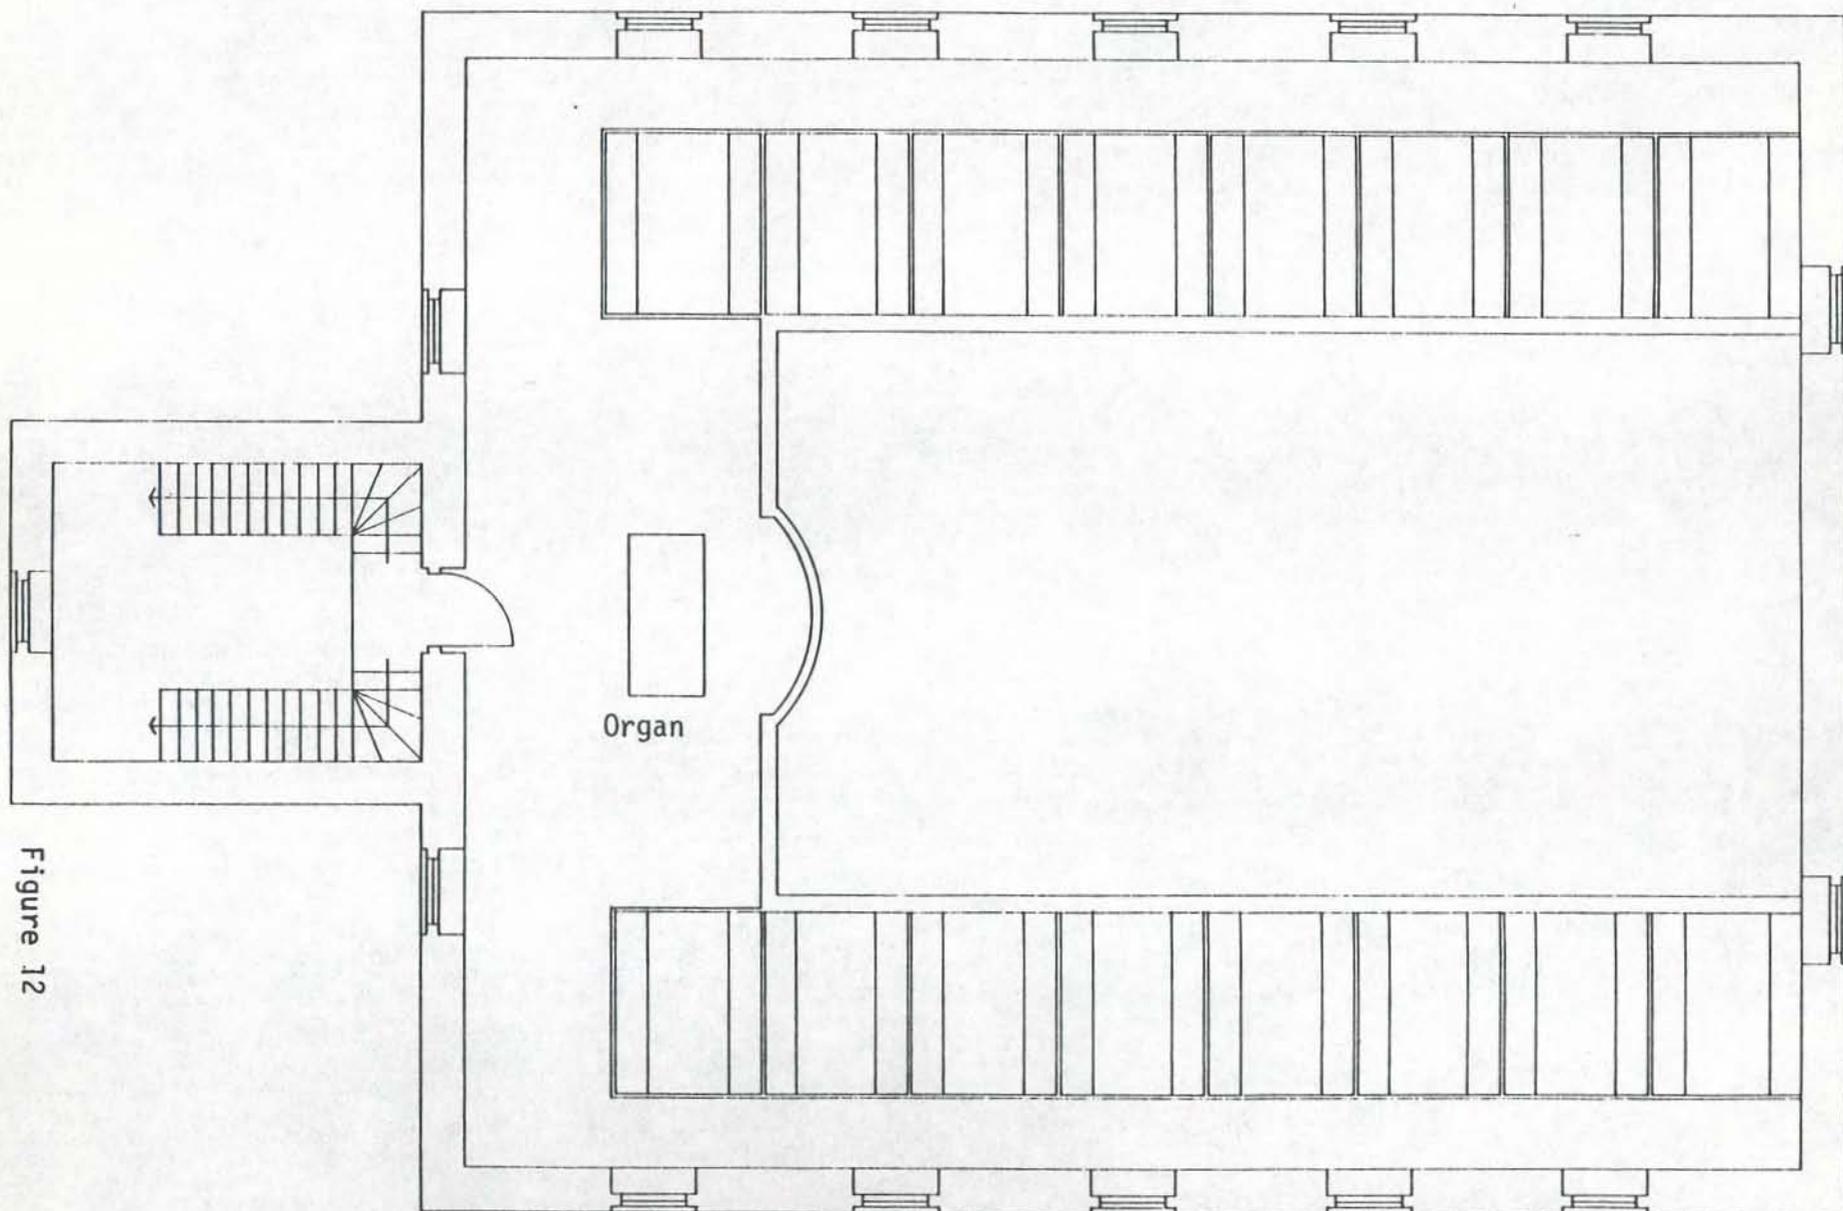
Figure 12

SECOND FLOOR PLAN: CIRCA 1785

(See
Figure 12)

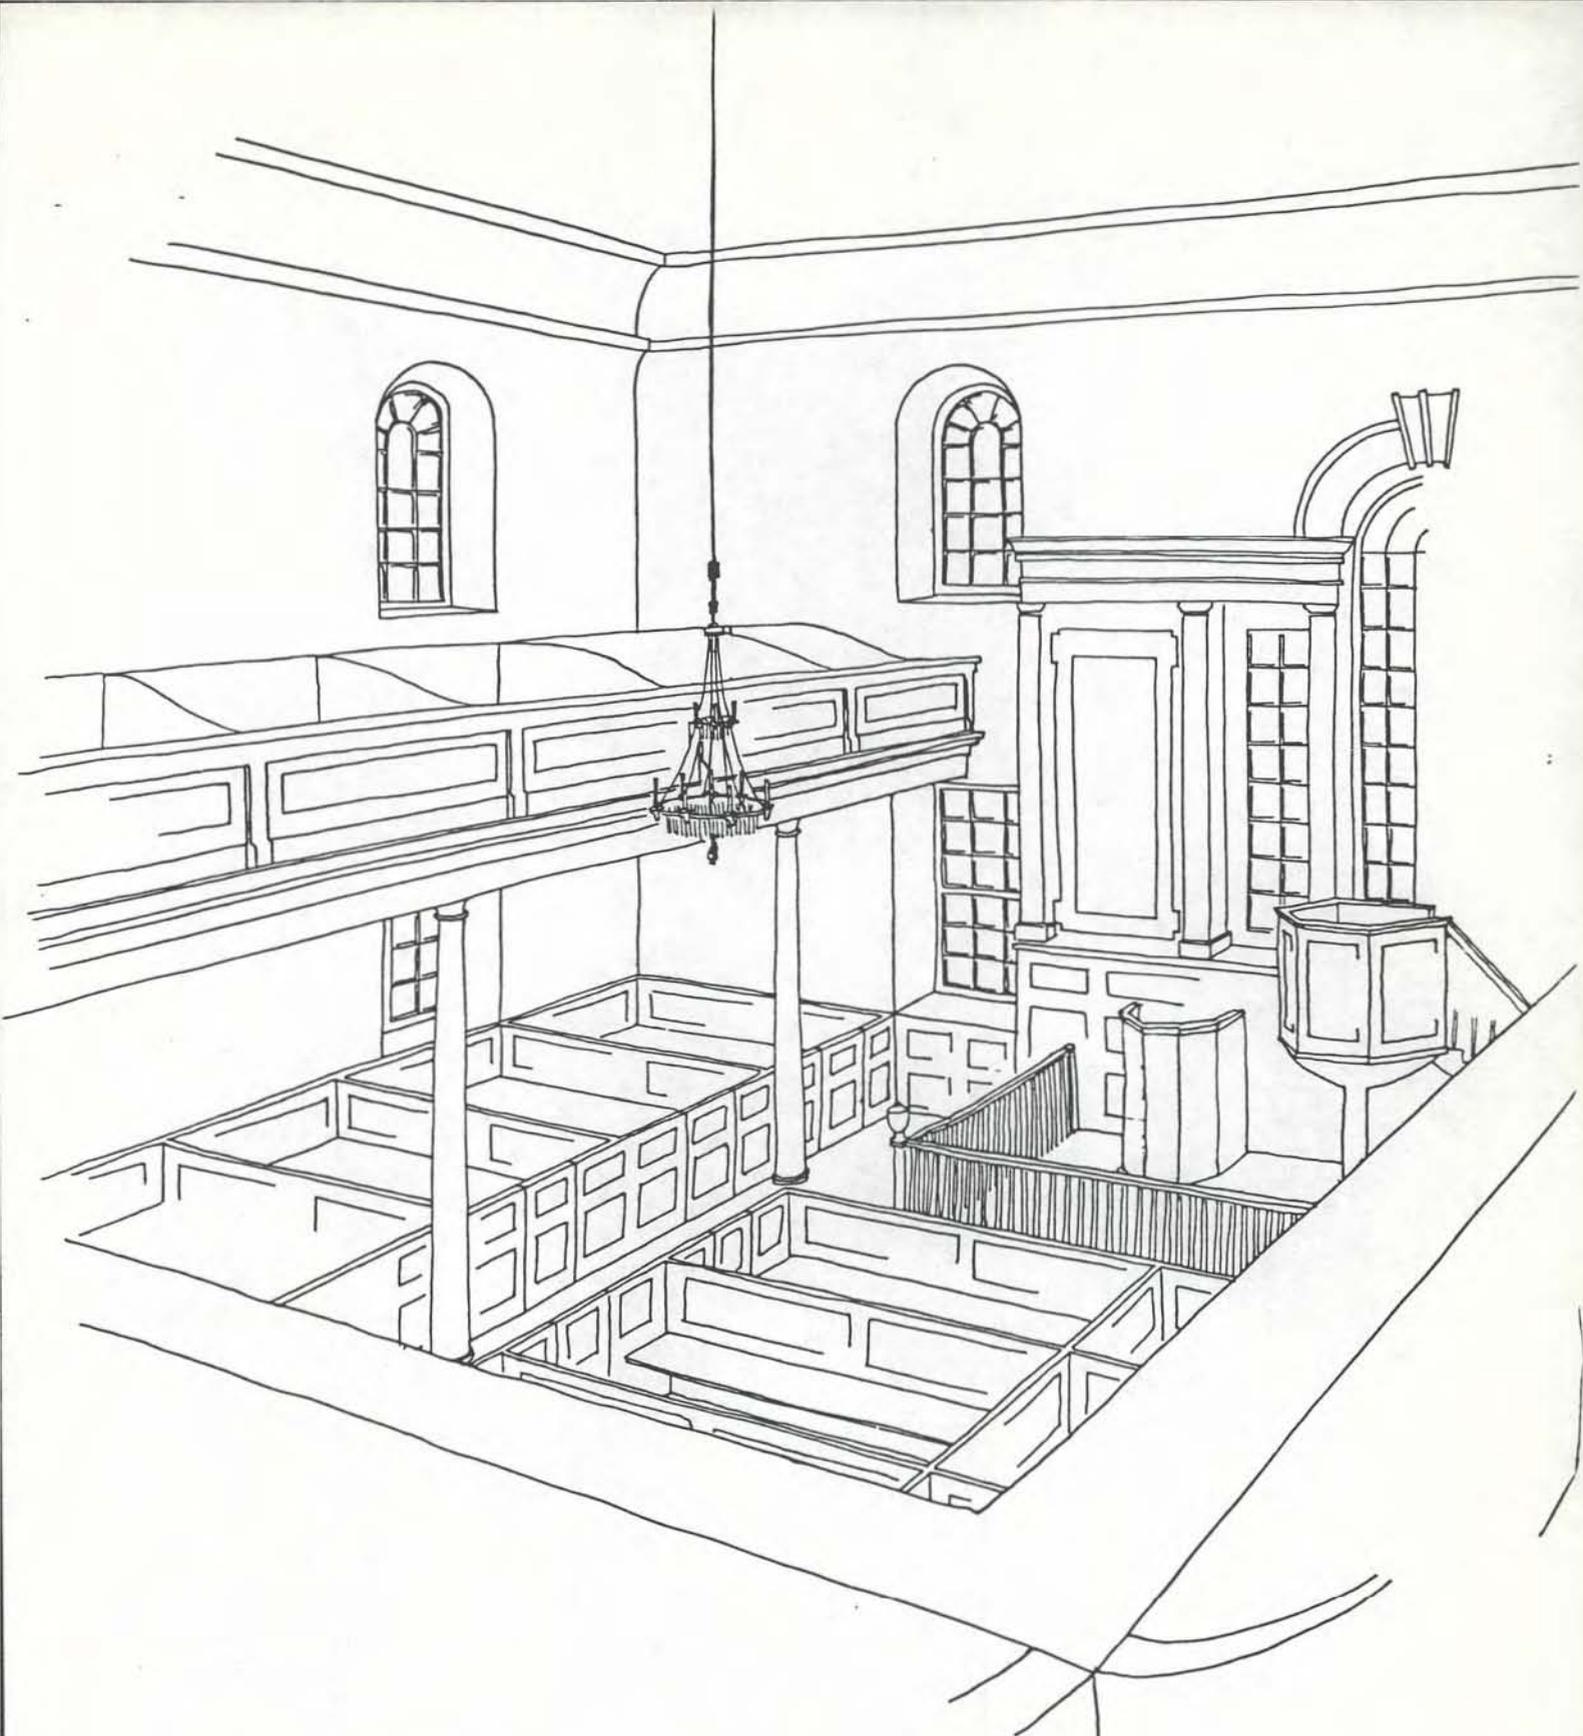
Figure 13

INTERIOR PERSPECTIVE looking east: CIRCA 1785

(See
Figure 13)

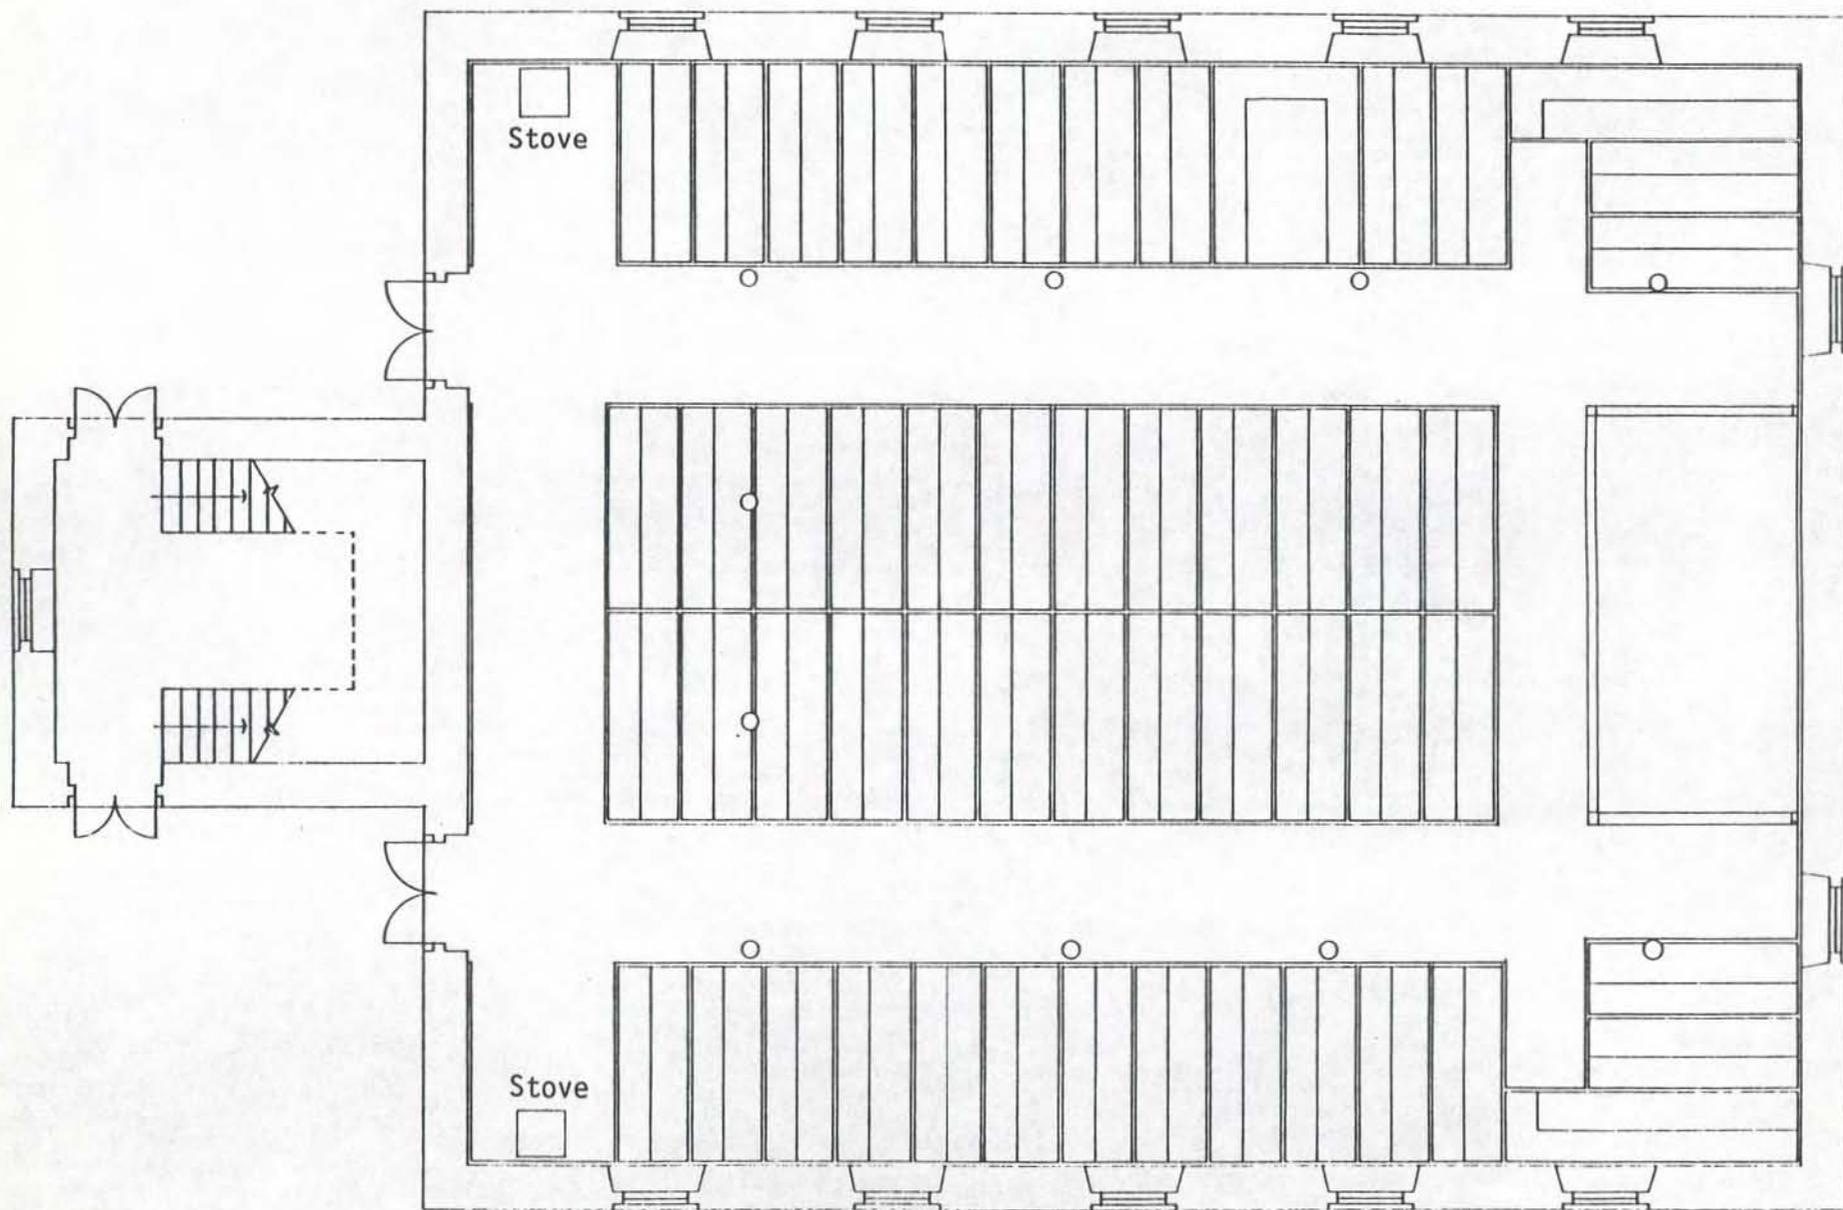
Figure 14

FIRST FLOOR PLAN: CIRCA 1816-21

The tower at its original conception could not have been intended as a vestibule for the first floor because of the lack of the west aisle similar to those in New England meeting houses; one must assume that its major function was access to the gallery. The west aisle in the Church was not cut in until 1811. Furthermore, the change in the aisle seems to have had little to do with the gallery but did serve two distinct purposes. The first was to restrict the use of both doors during inclement weather by allowing congregants to enter one door and then pass through the rear of the Church to the opposite aisle, and second, to accommodate heating stoves and

(See
Figure 14)

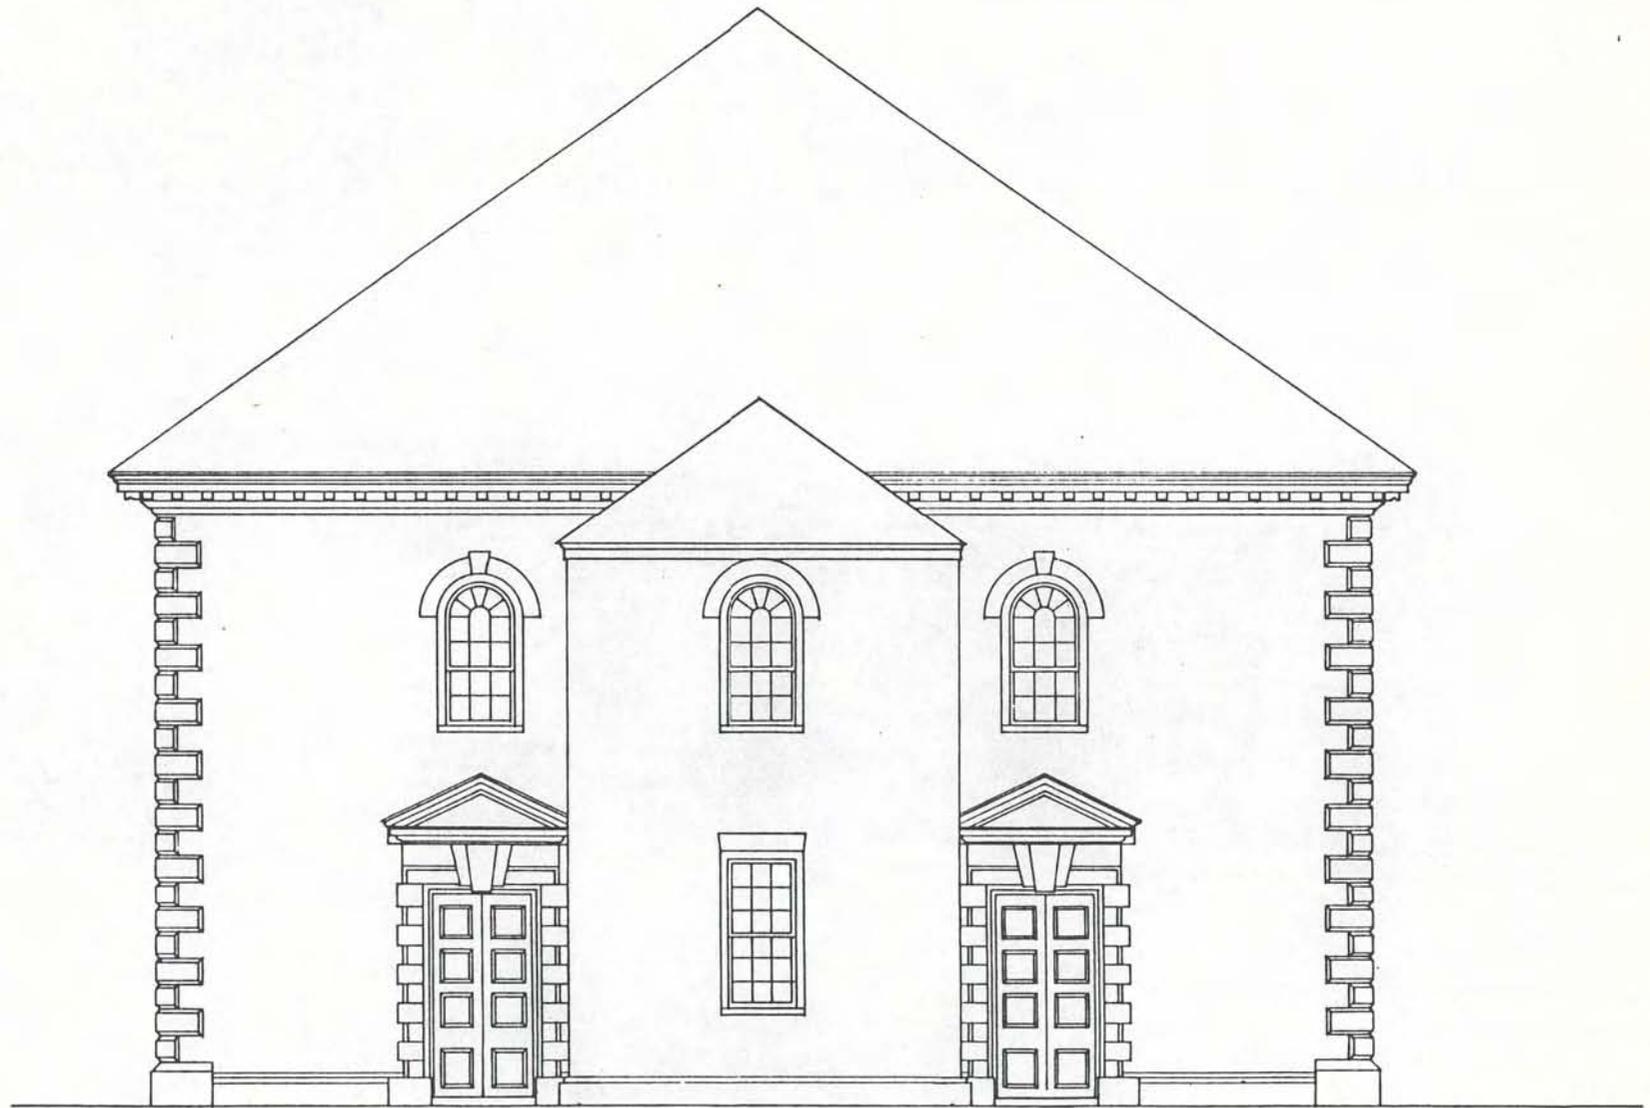
Figure 15

WEST ELEVATION: CIRCA 1785

(See
Figure 15)

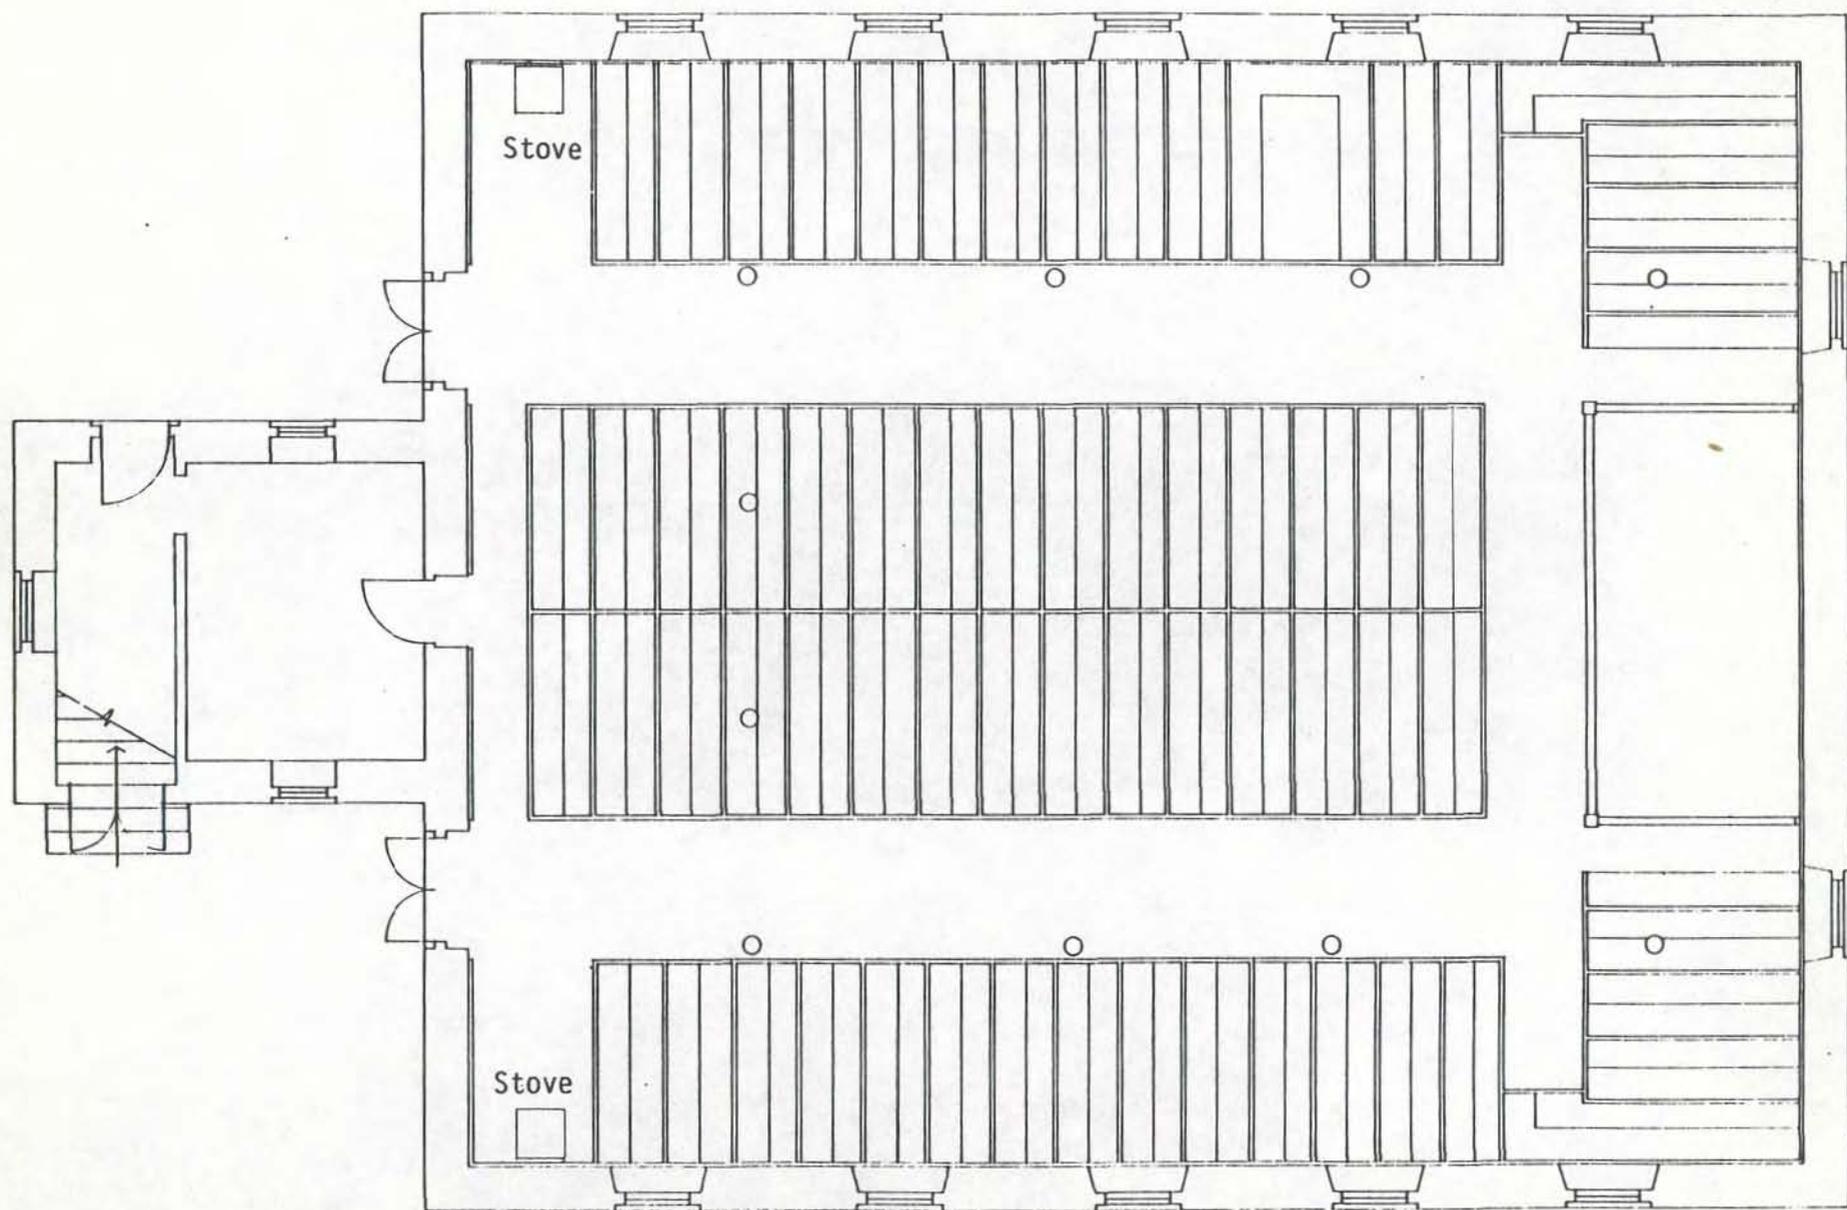
Figure 16

FIRST FLOOR PLAN: CIRCA 1834-40

(See Figure 16)

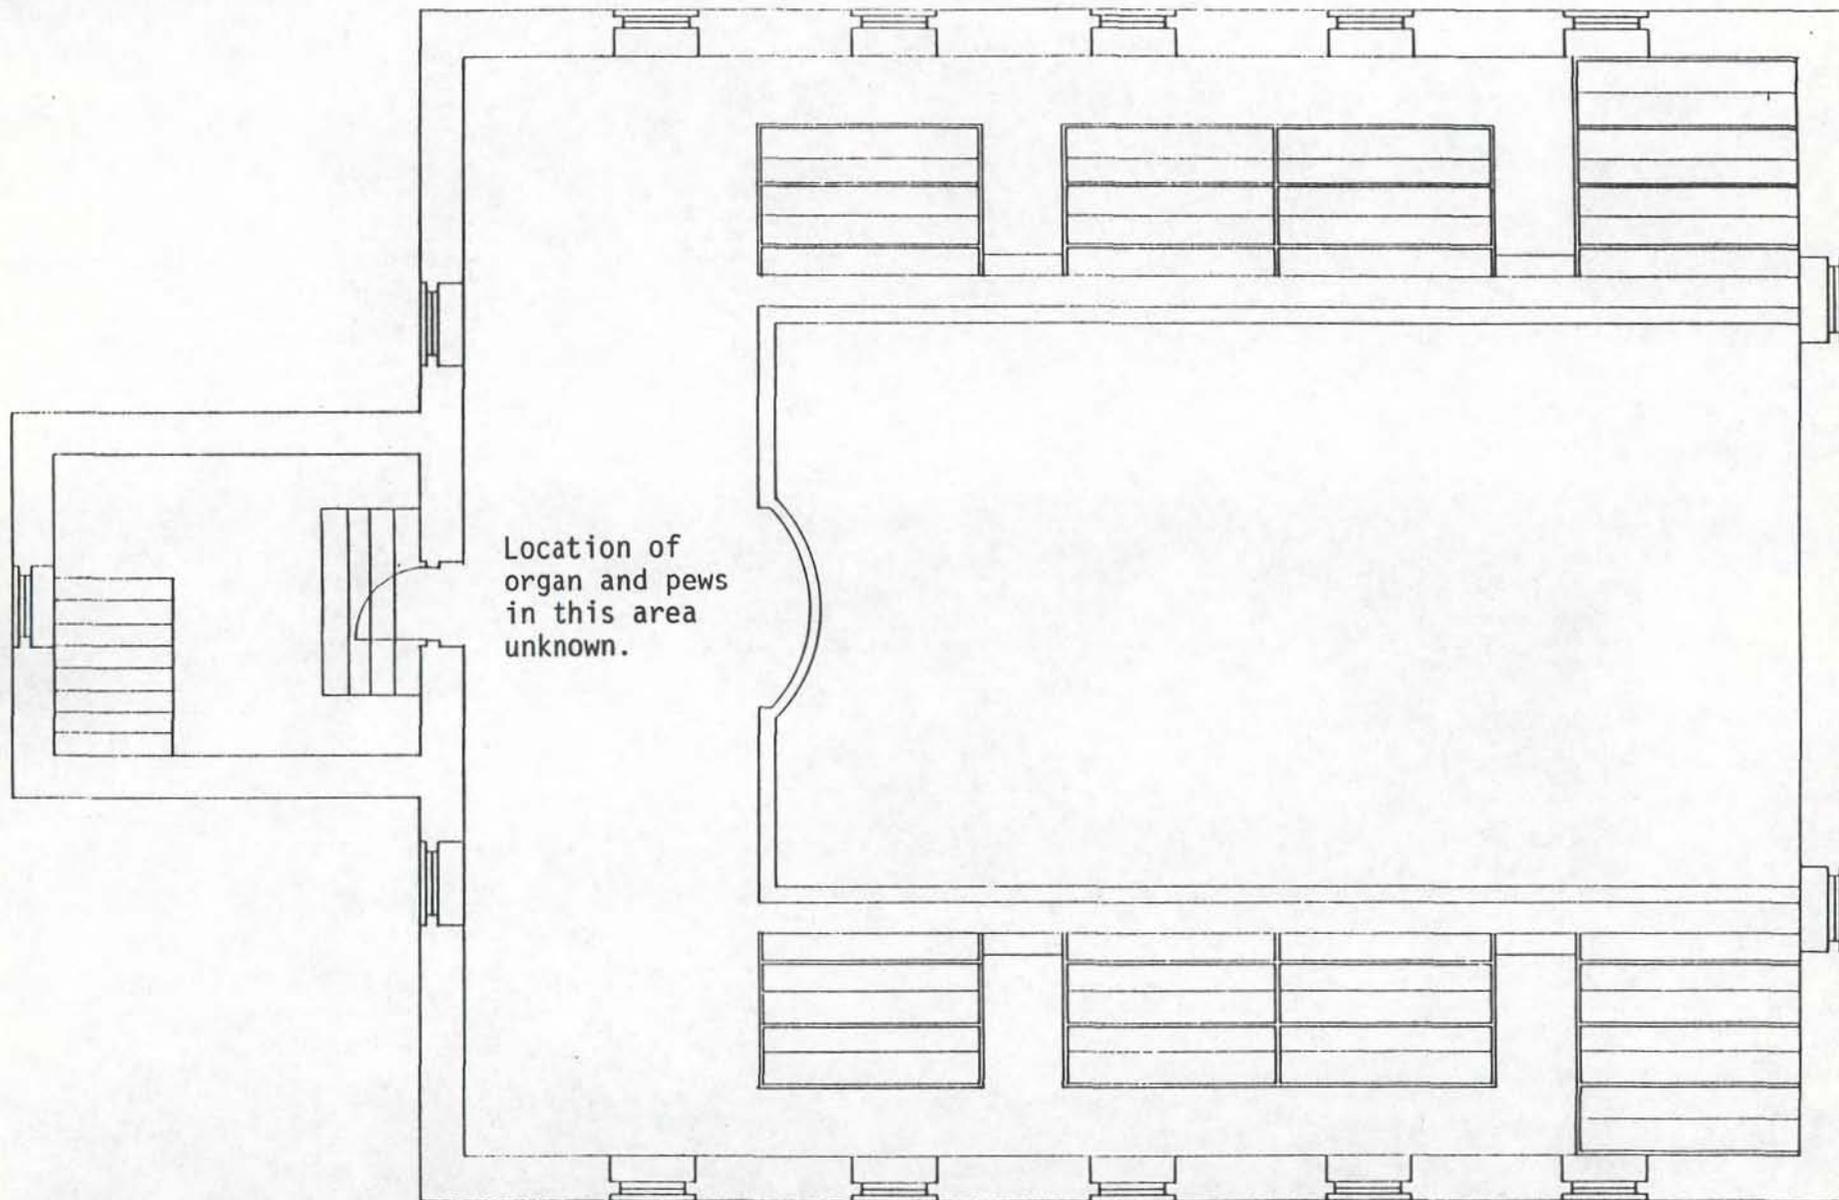
Figure 17

SECOND FLOOR PLAN: CIRCA 1834-40

(See Figure 17)

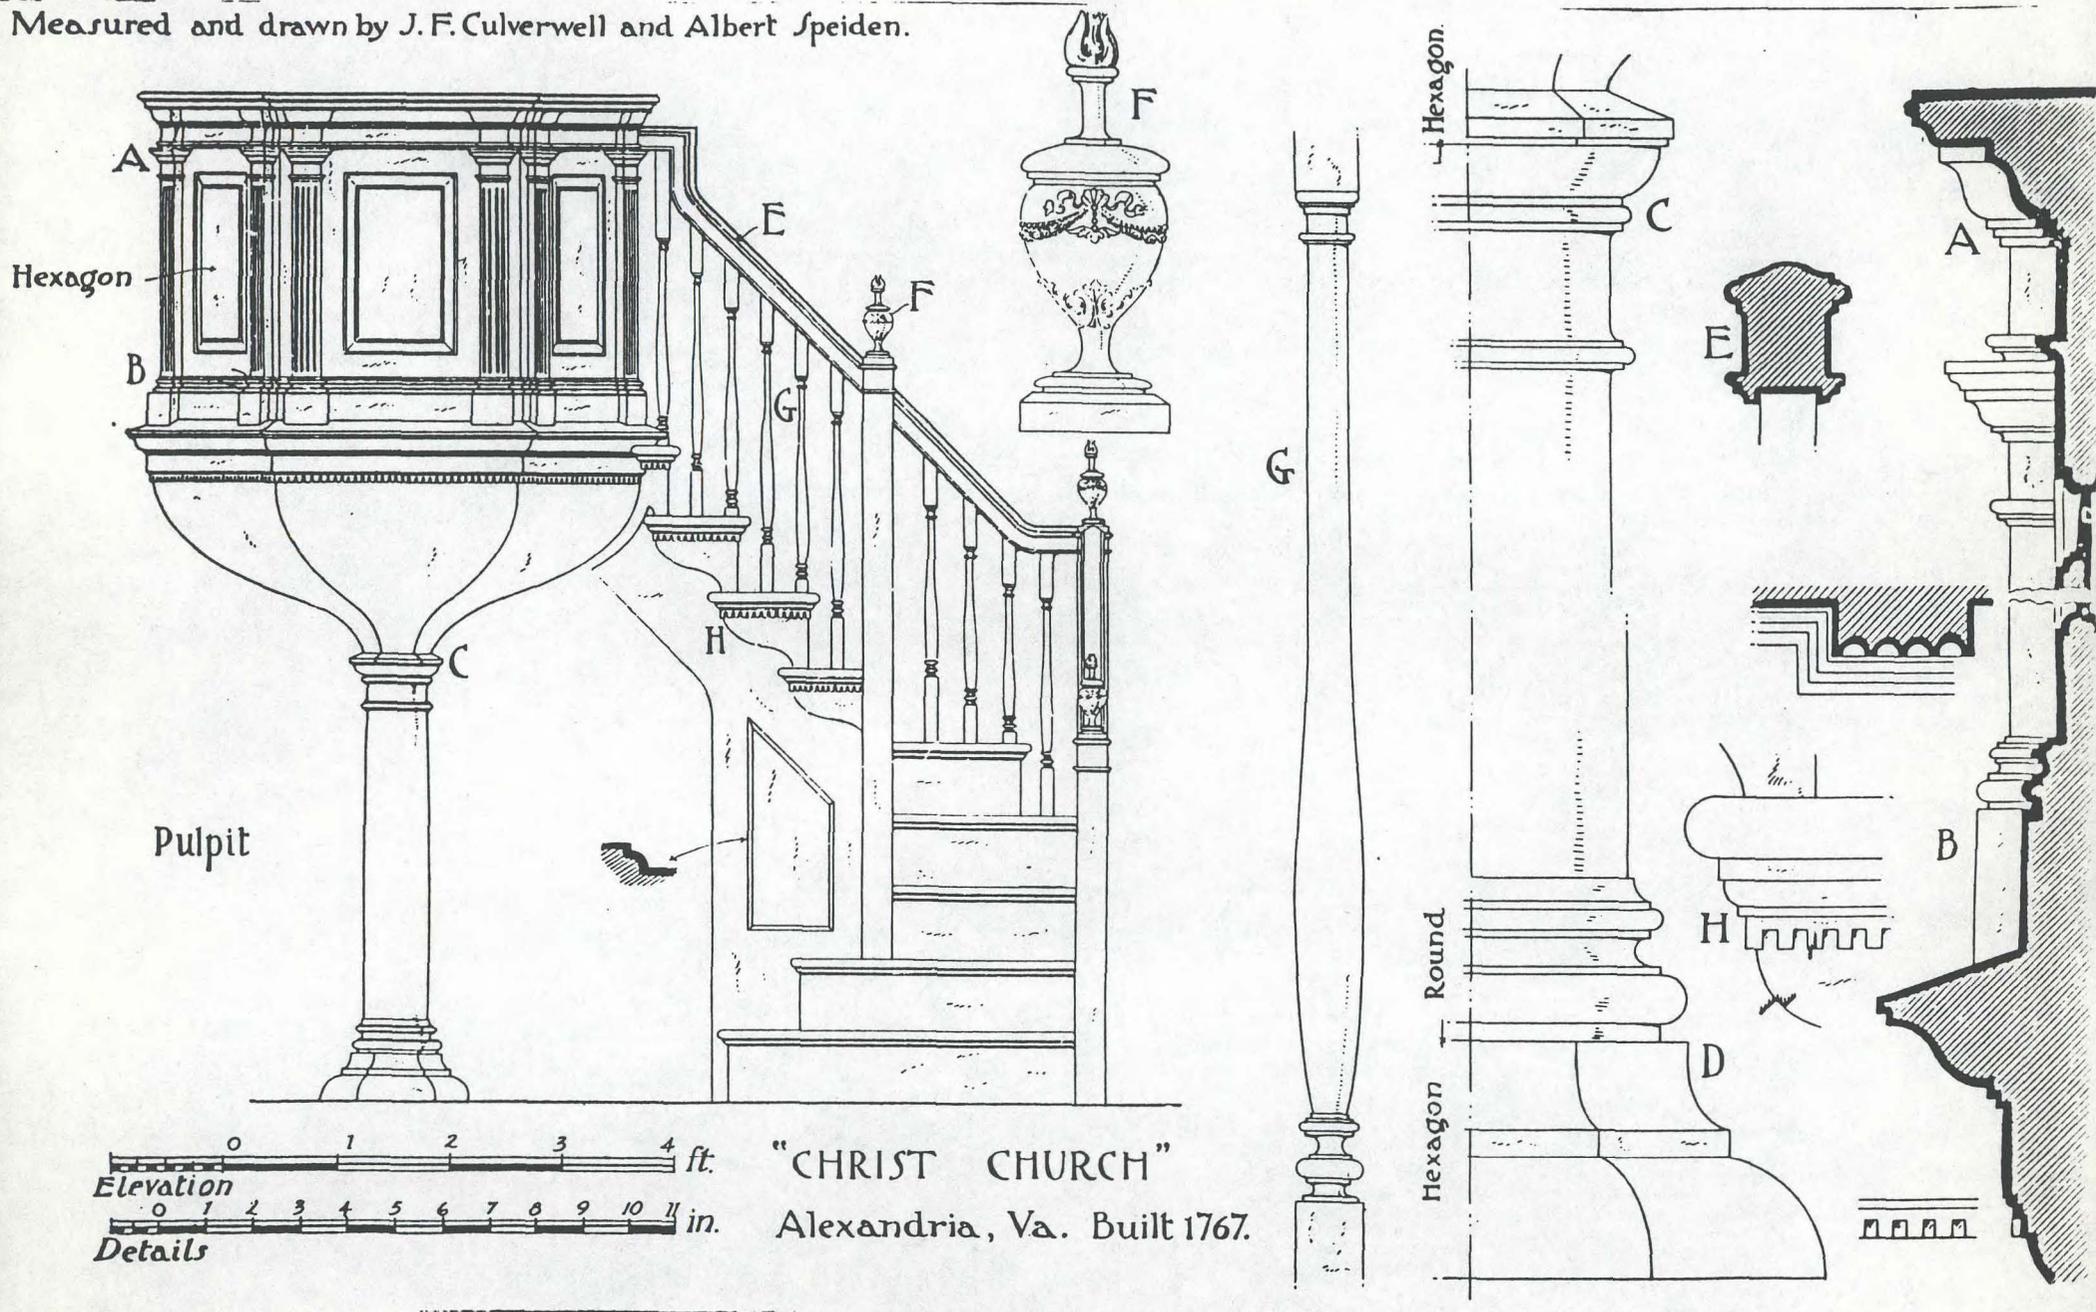
Measured and drawn by J. F. Culverwell and Albert Speiden.

"CHRIST CHURCH"
Alexandria, Va. Built 1767.

Figure 18 Detail of Pulpit

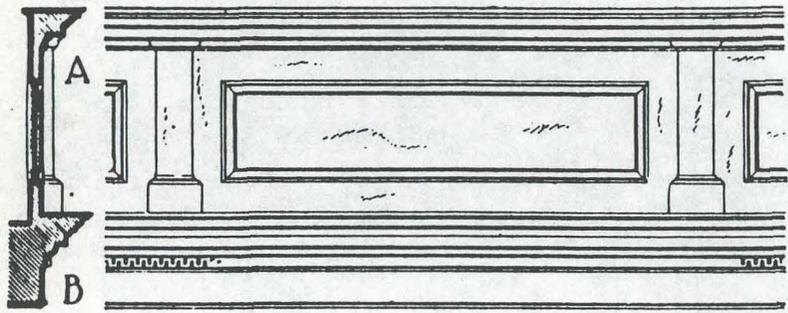
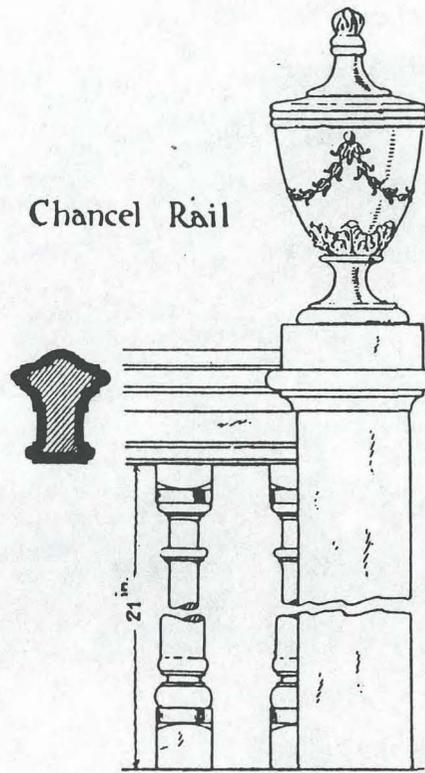
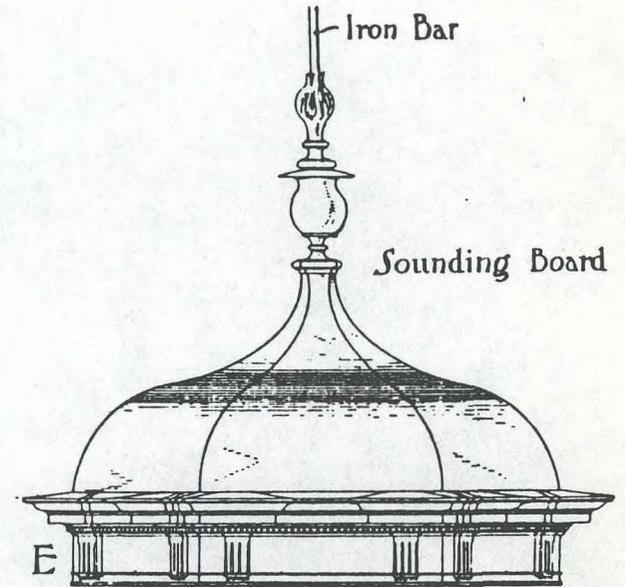
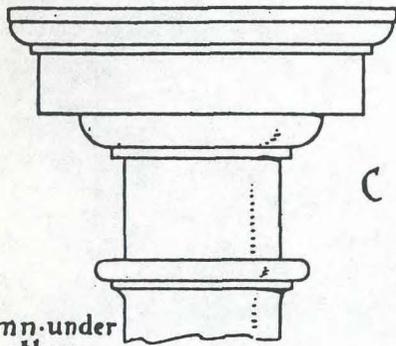
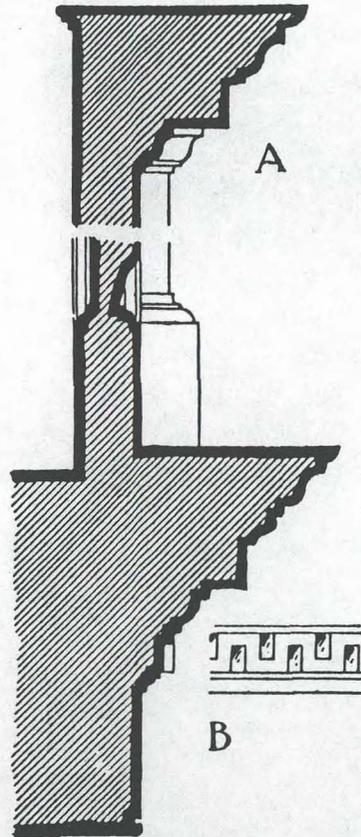
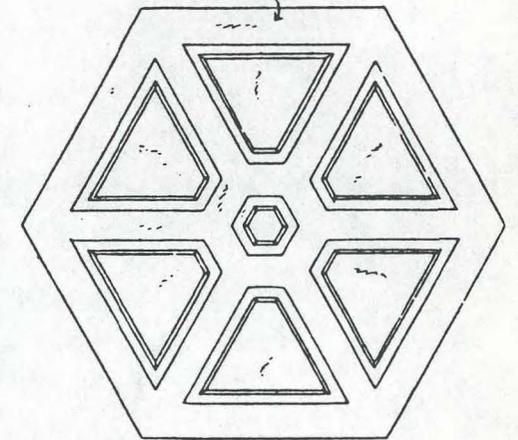
Gallery Front

Chancel Rail

Sounding Board

Figure 19 Detail of Sounding Board and Chancel Rail

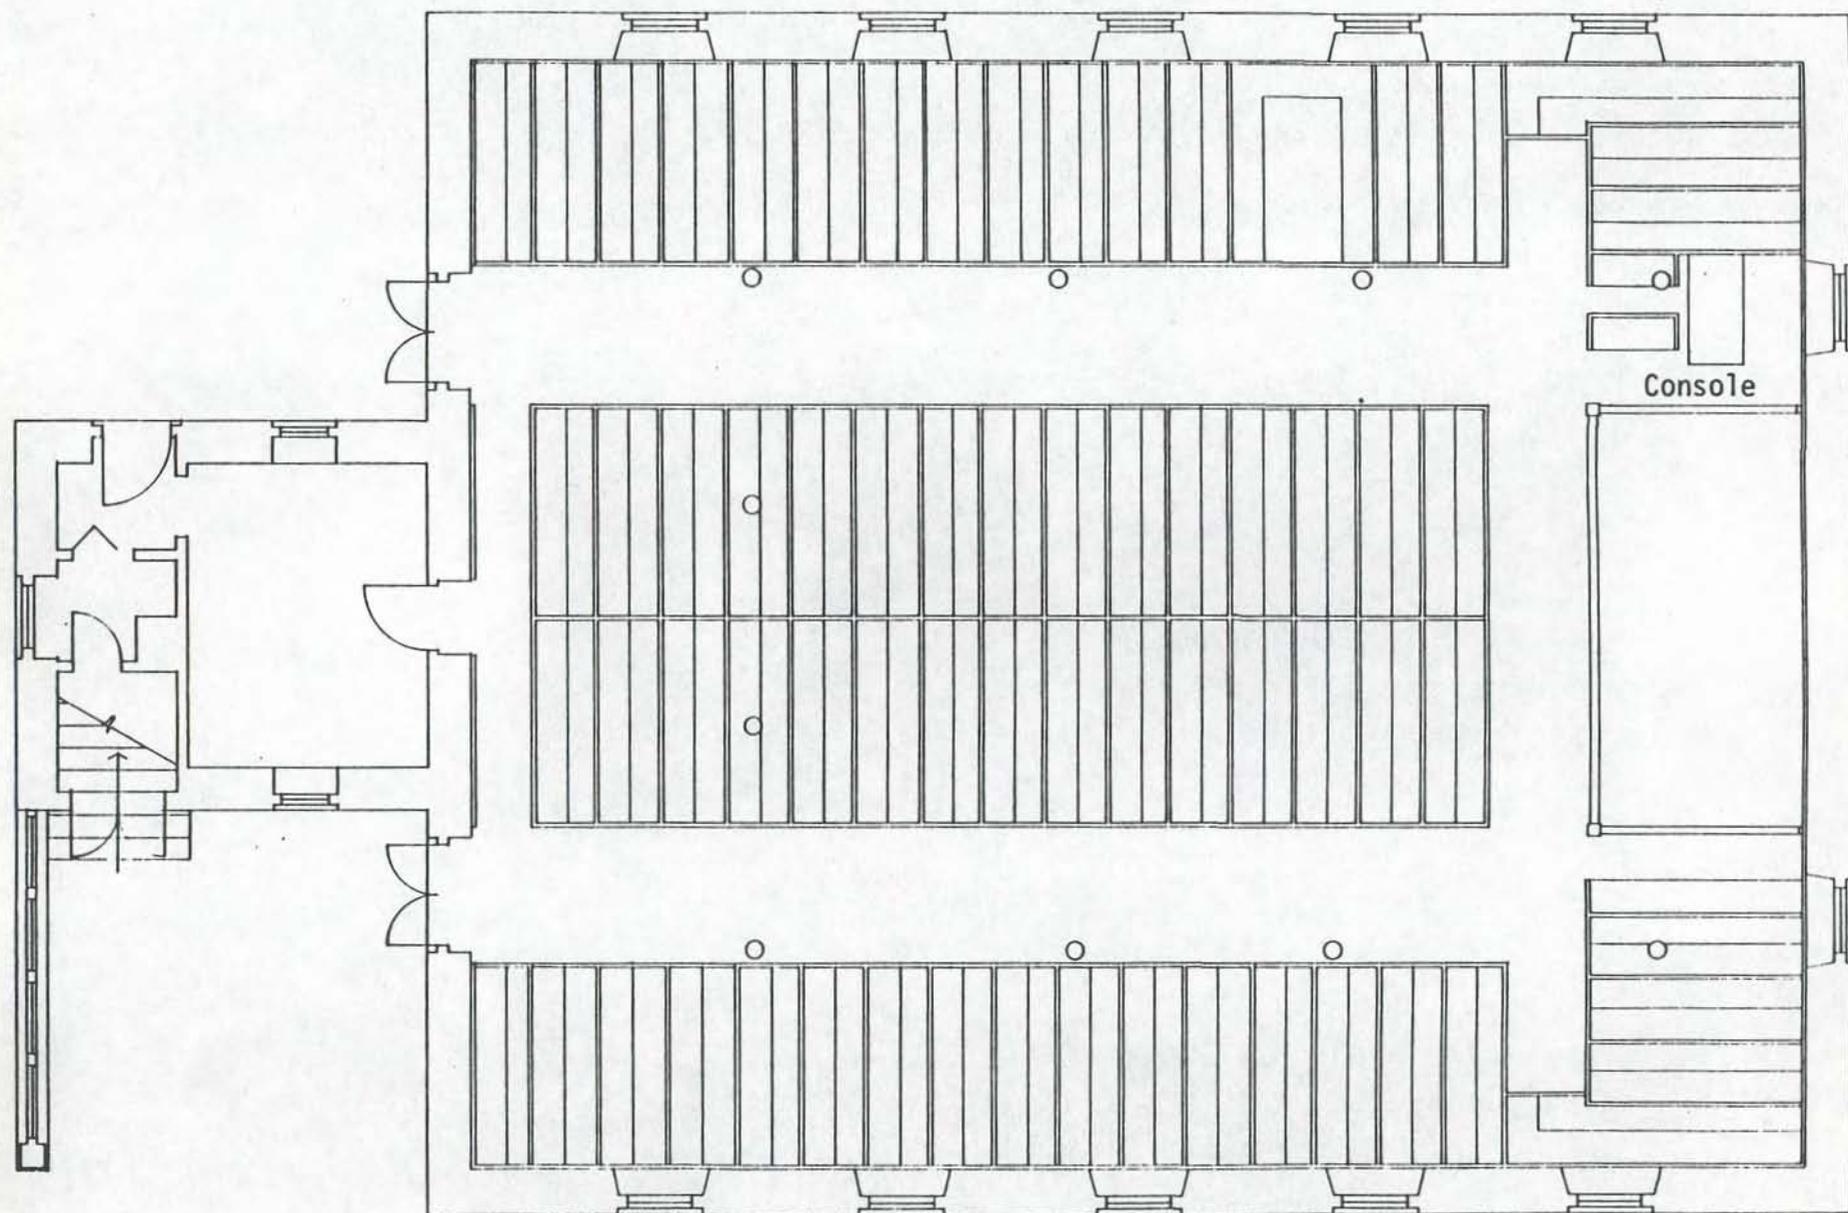
Figure 20

FIRST FLOOR PLAN: CIRCA 1921

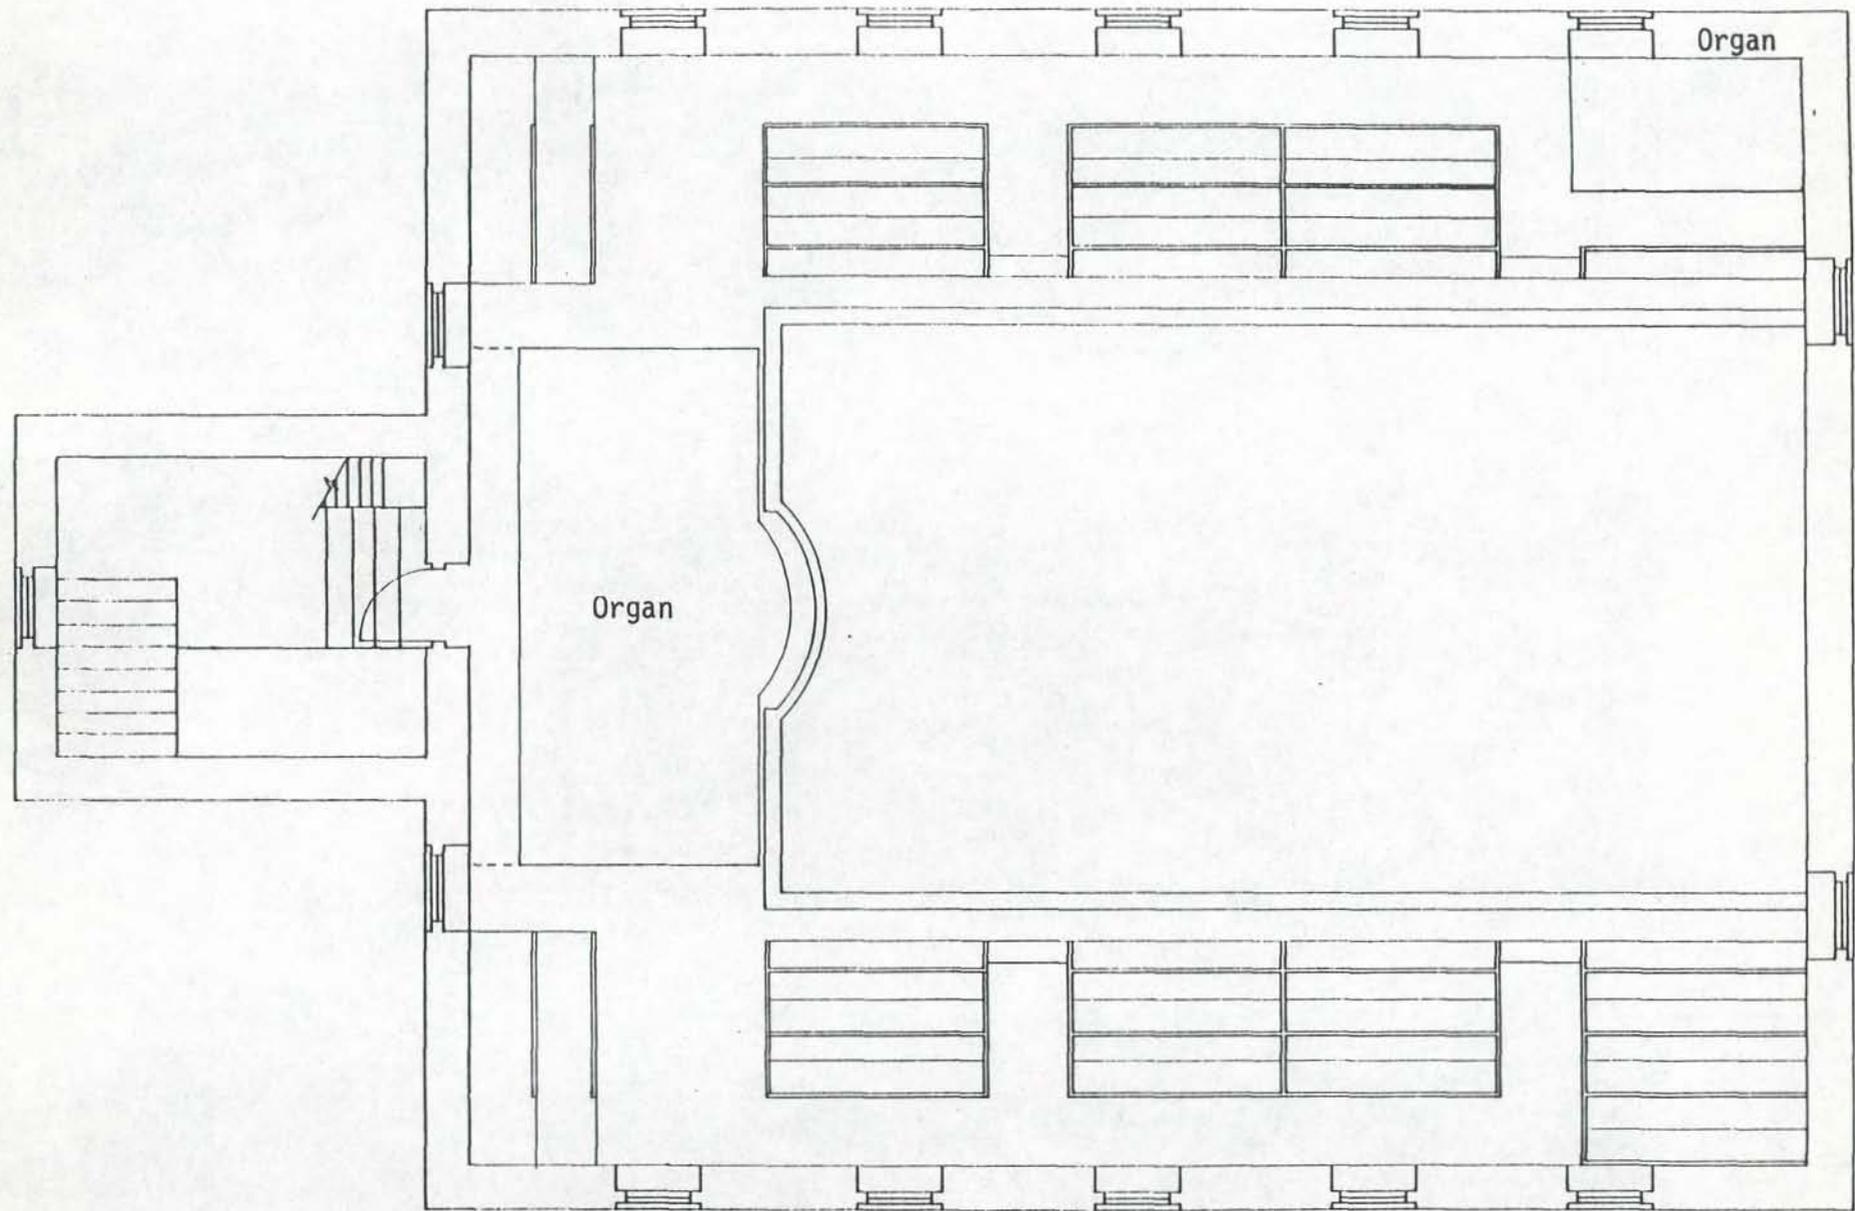
Figure 21

SECOND FLOOR PLAN: CIRCA 1921
