CHRIST CHURCH

THE HISTORIC STRUCTURE REPORT

CHRIST CHURCH
ALEXANDRIA, VIRGINIA

John Milner Associates
309 North Matlack Street
West Chester, Pennsylvania

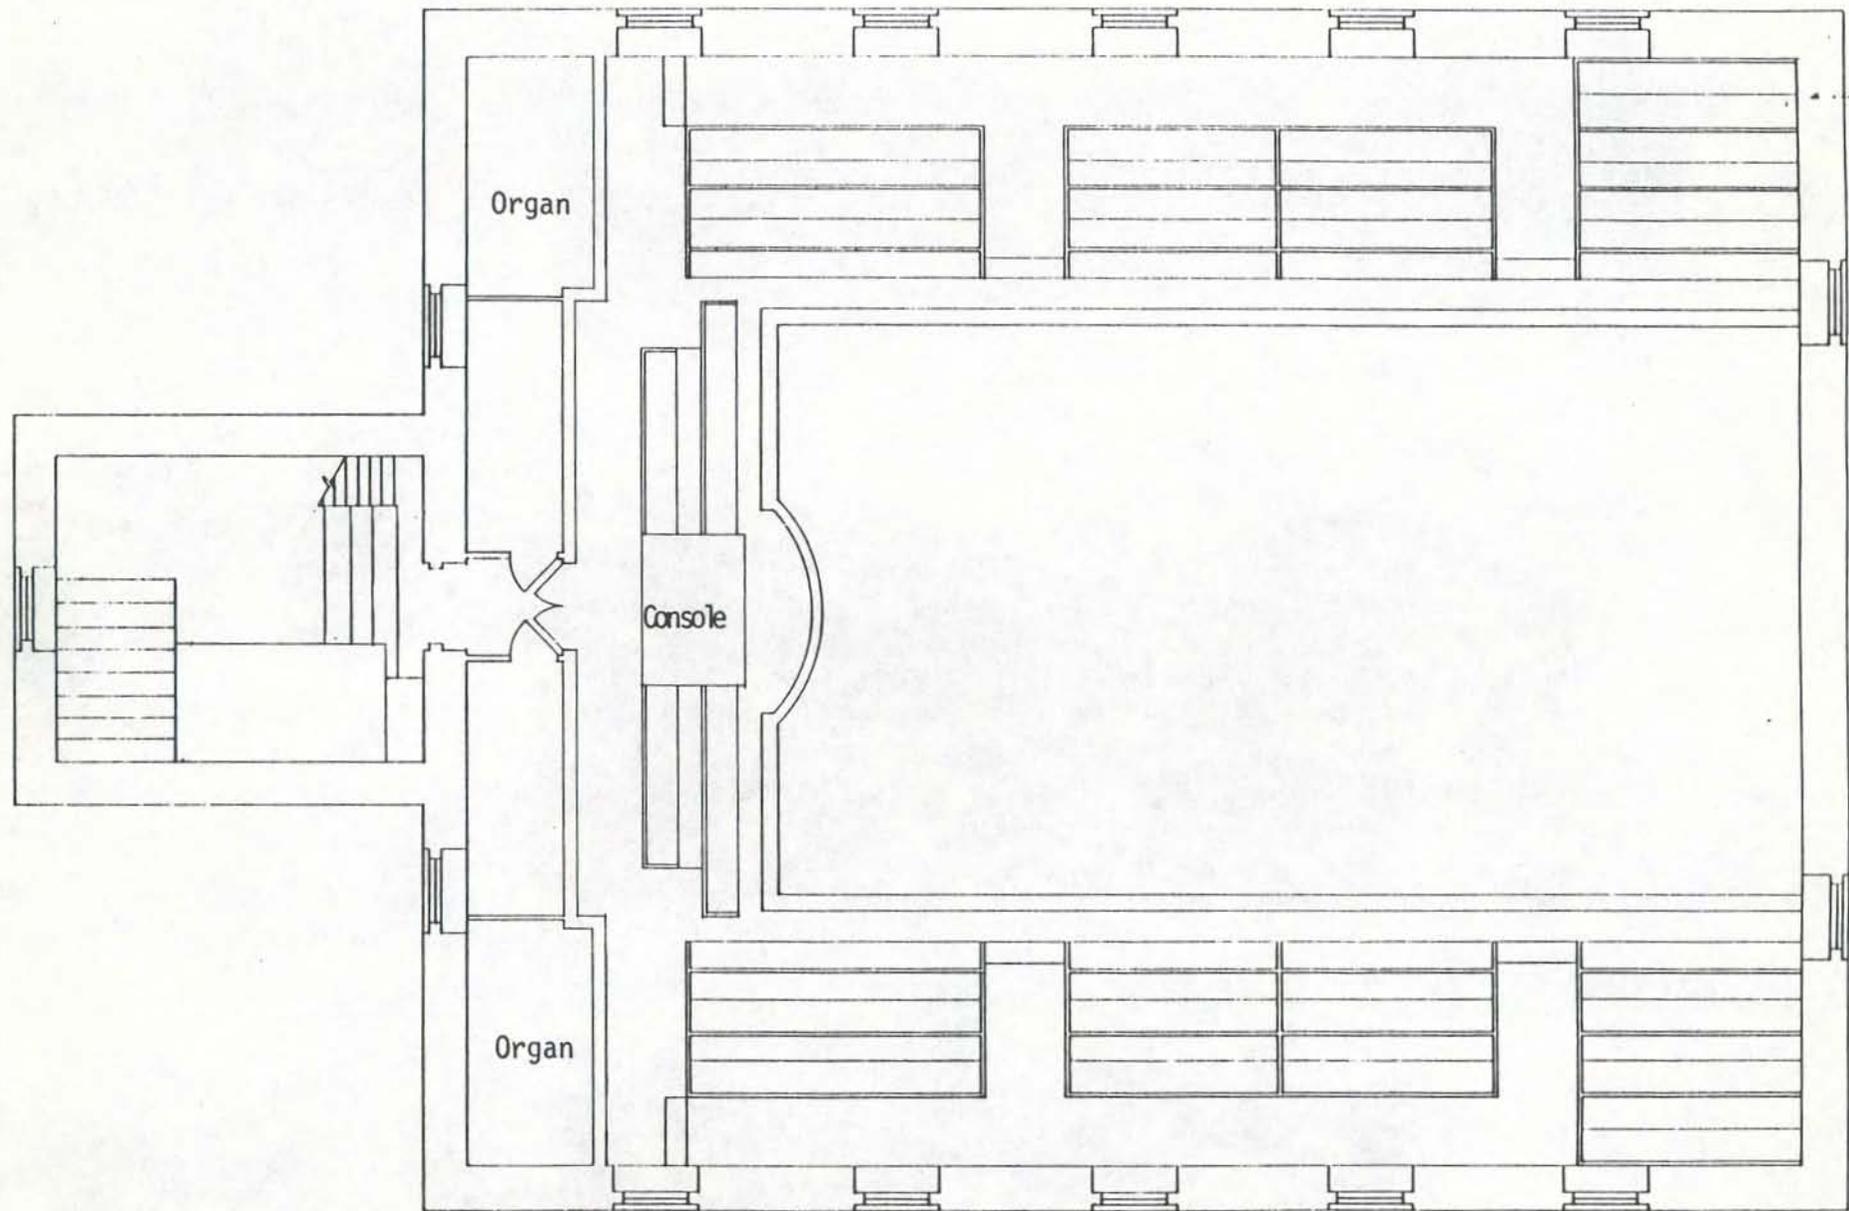
Figure 26

SECOND FLOOR PLAN: CIRCA 1950

(See
Figure 26)

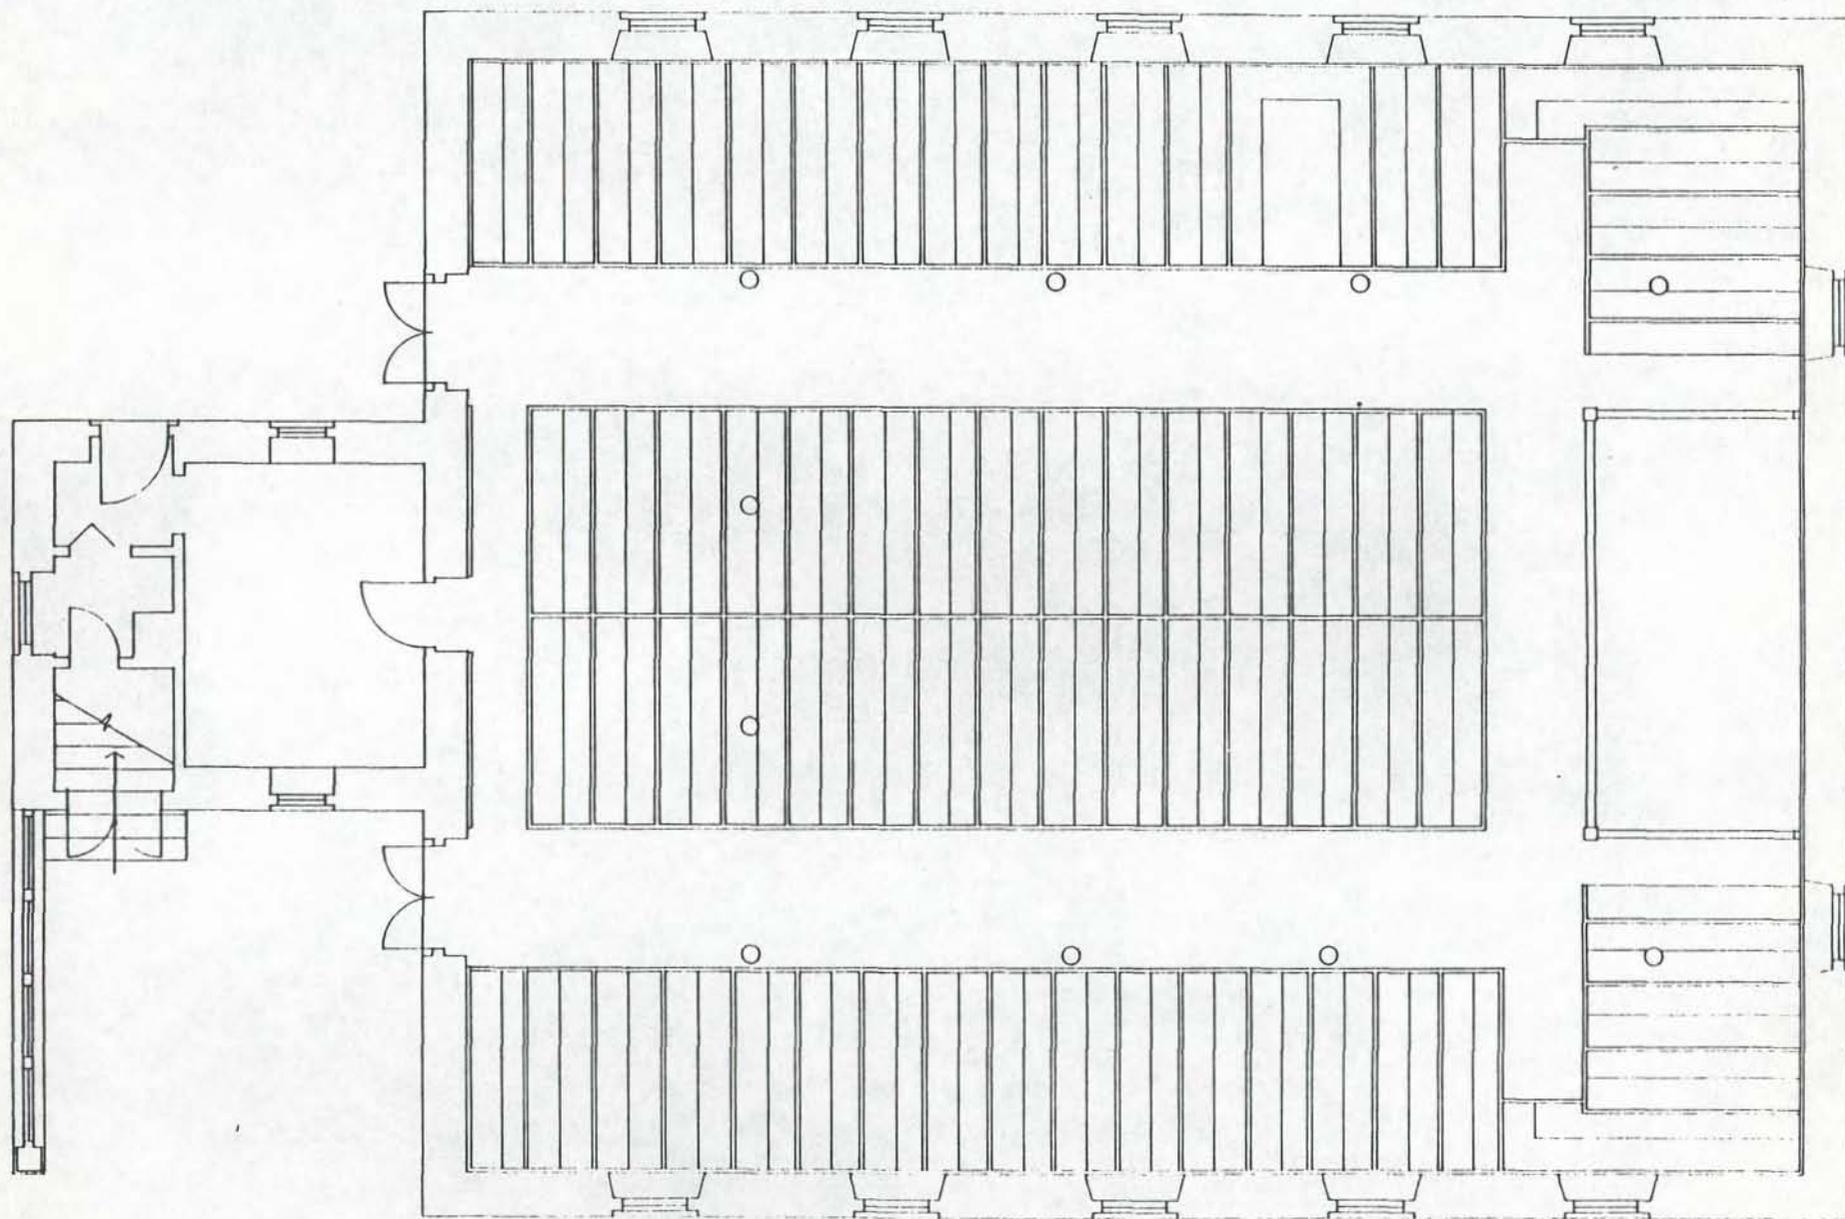
Figure 27

FIRST FLOOR PLAN: PRESENT

(See
Figures
27 & 28)

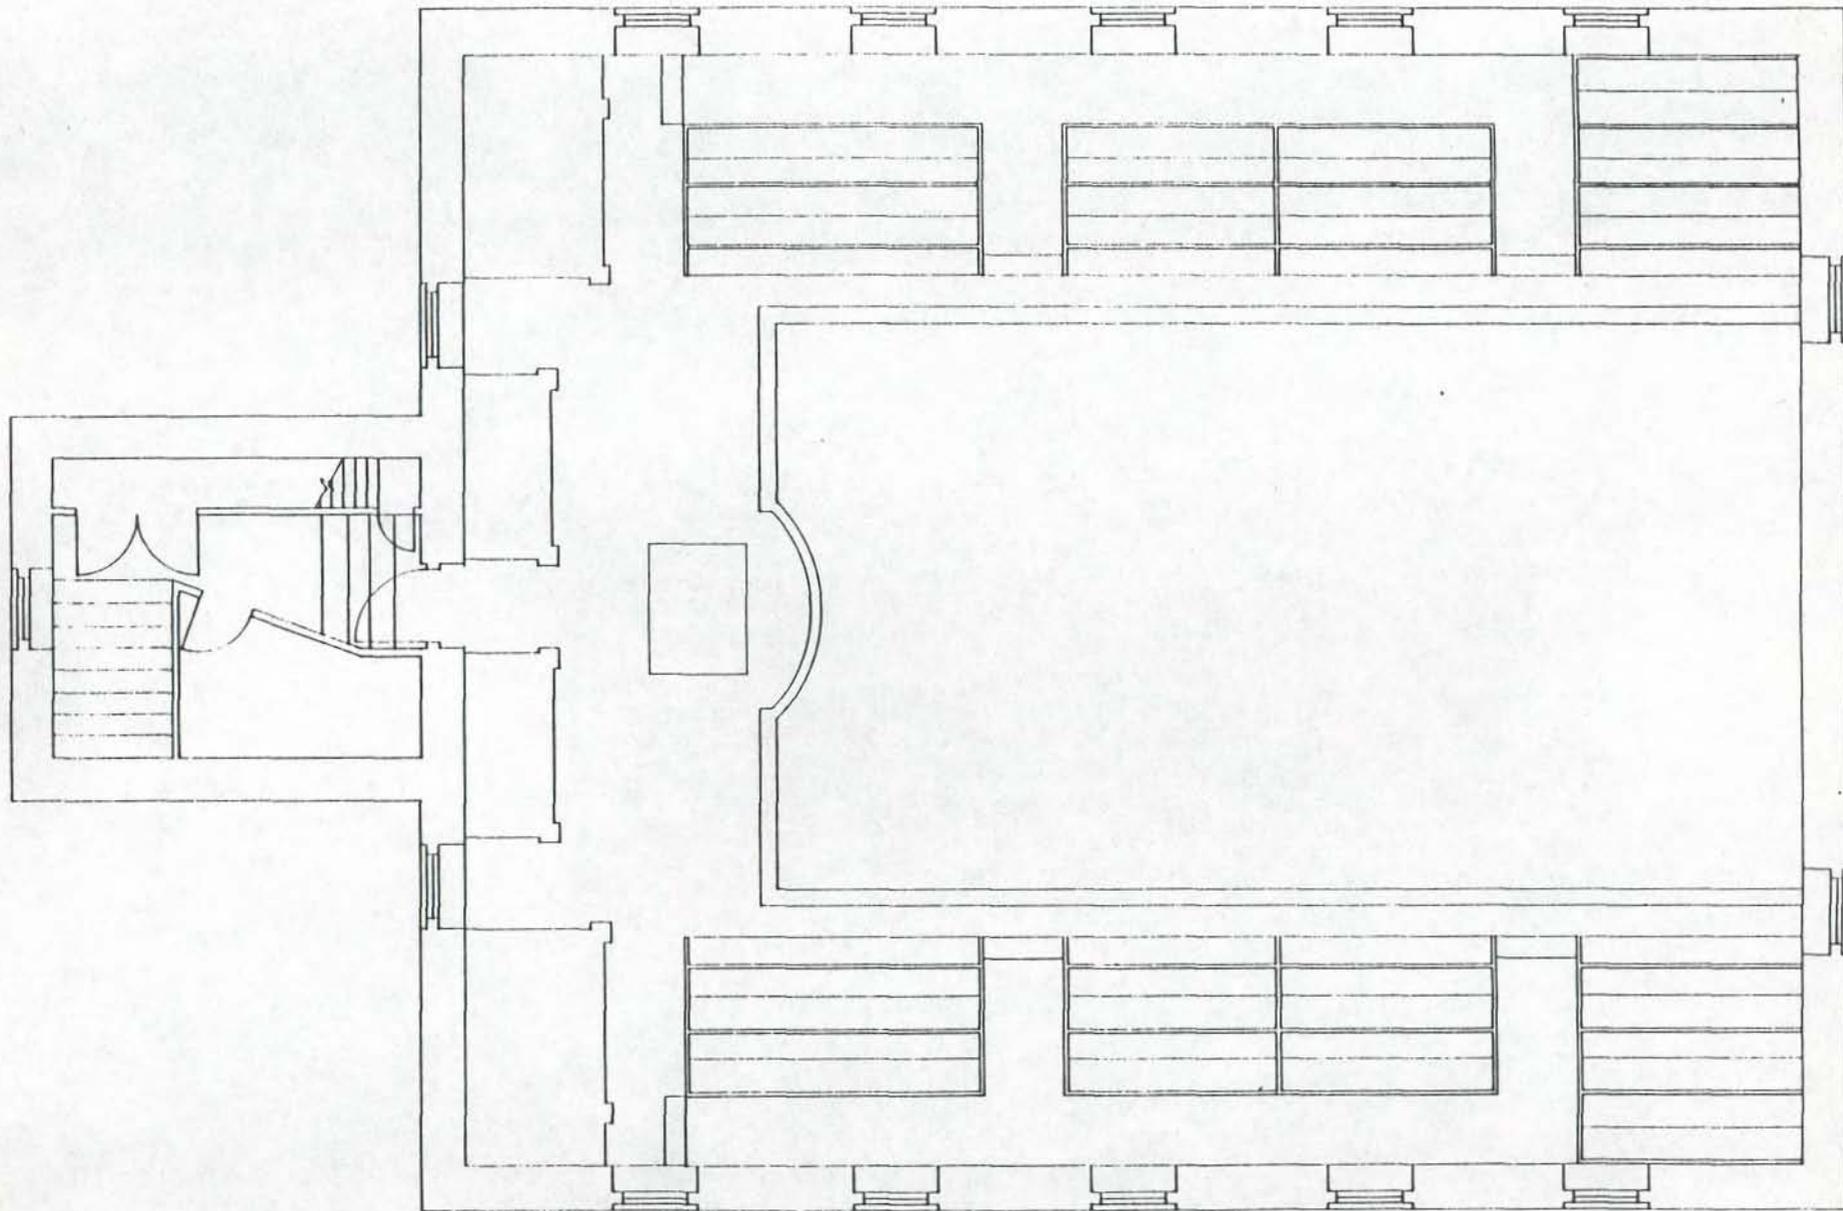
Figure 28

SECOND FLOOR PLAN: PRESENT

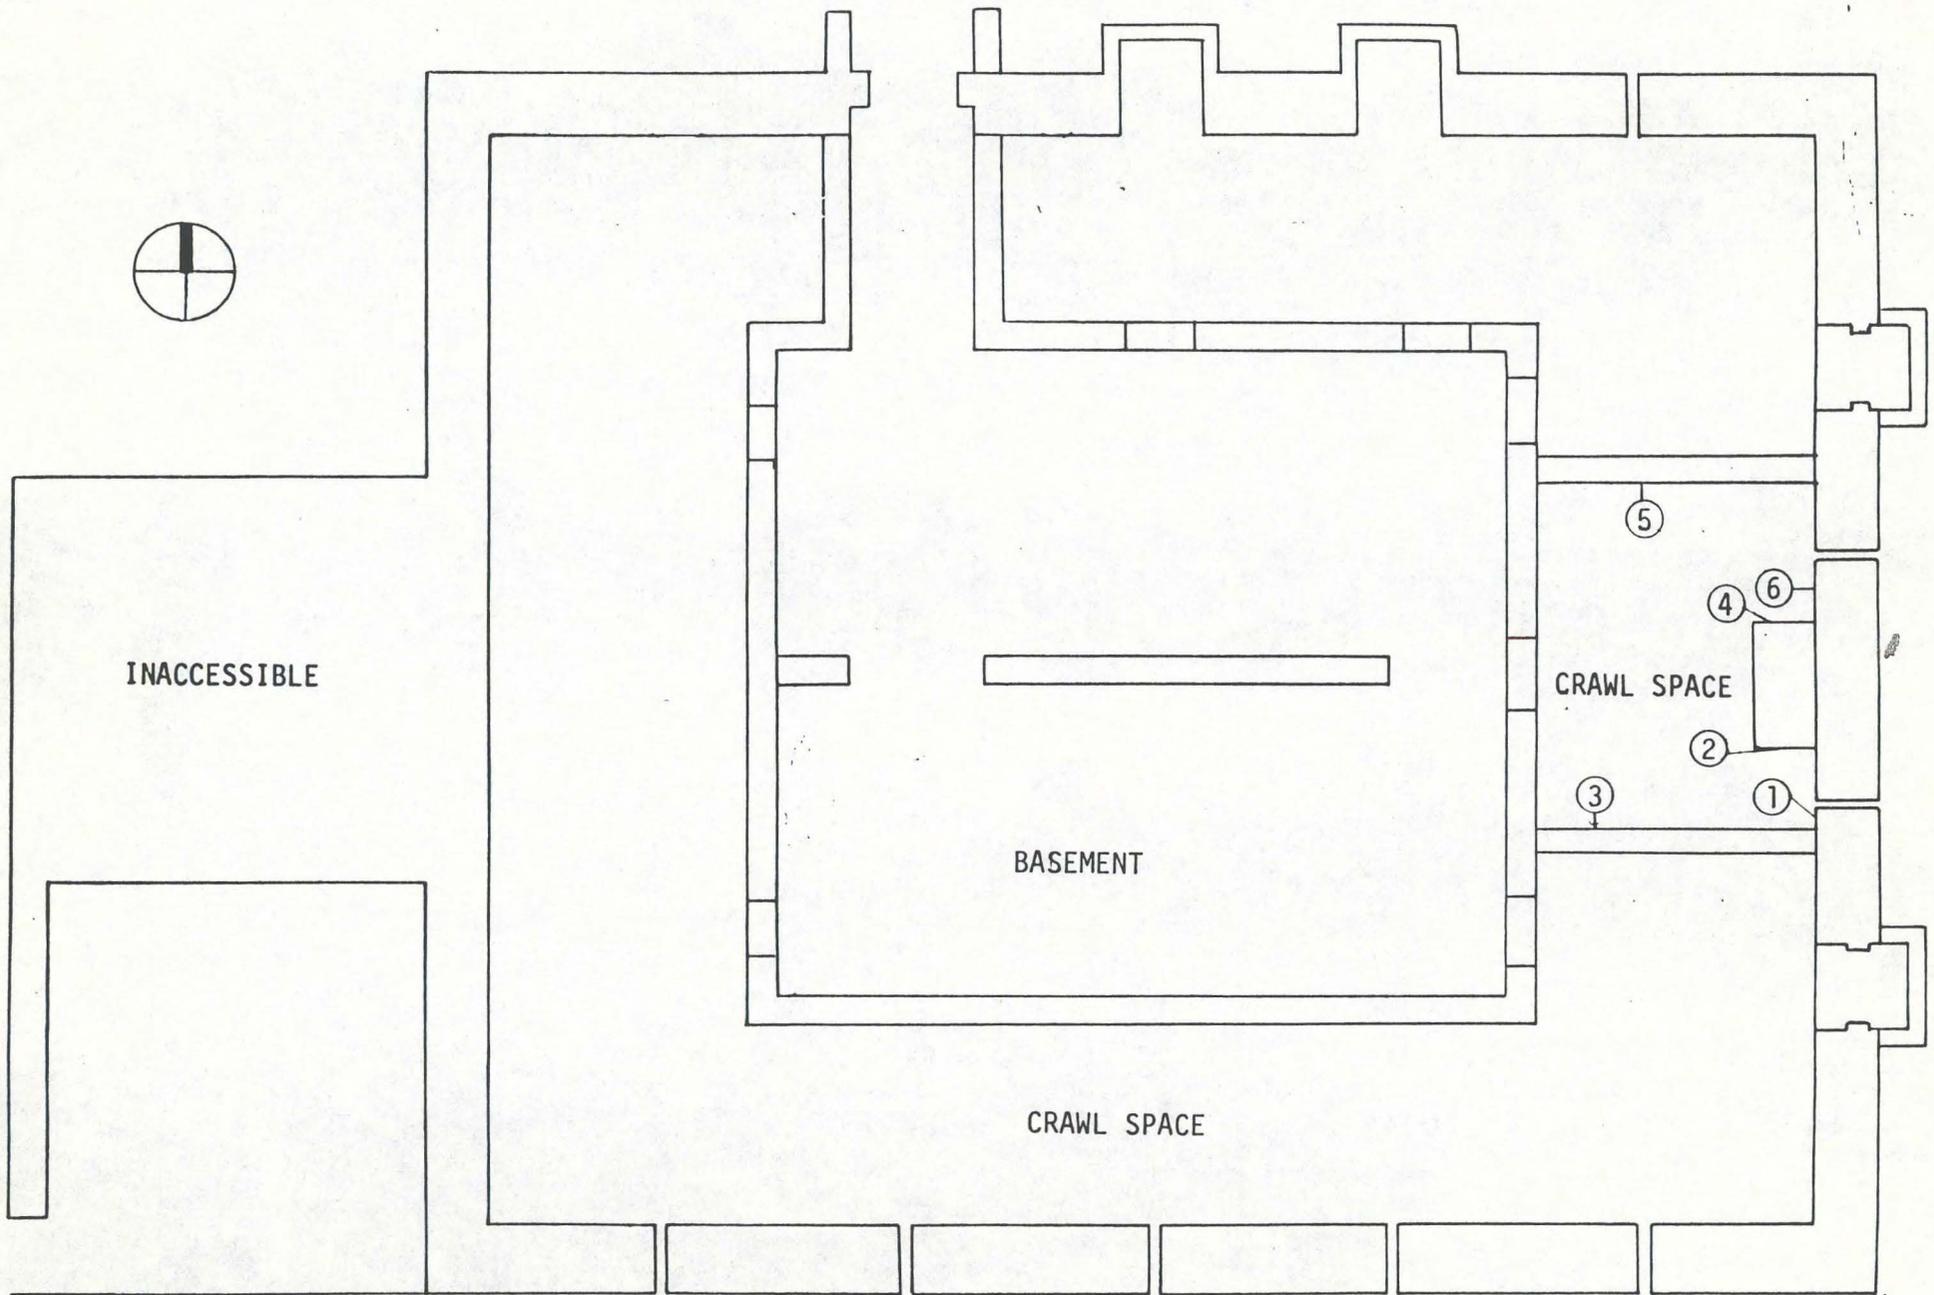
Eight samples of building mortar from Christ Church, Alexandria, Virginia, were subjected to a physical and chemical analysis. Six of the samples were taken from the basement crawl space under the Chancel; two were taken from above the doorway to the vestry room. Chemical analysis involved the use of hydrochloric acid in the manner outlined by Blaine Cliver (1974). Physical analysis involved careful examination with the naked eye and under a low-power microscope for color, inclusions, angularity, hardness, and size. The interpretation of each sample is described on the following pages and should be used in reference with the attached data sheets.

MORTAR SAMPLES LOCATIONS
 8/29/79
 JOHN MILNER ASSOCIATES

BASEMENT
 CHRIST CHURCH
 ALEXANDRIA, VA.
